**RE: *Item 10.2 – October 20, 2020 City Council Agenda:
C19-013, CP19-013 and T20-015 – Conforming Rezoning, Conditional Use Permit,
and Tentative Map for Certain Real Property Located at 550-570 Meridian Avenue,
1401 Parkmoor Avenue, and 529, 592, and 691 Race Street***

San Jose Vasona Quiet Zone Diagnostic Review Comments & Responses

DATE: August 6, 2019 (Day 1)

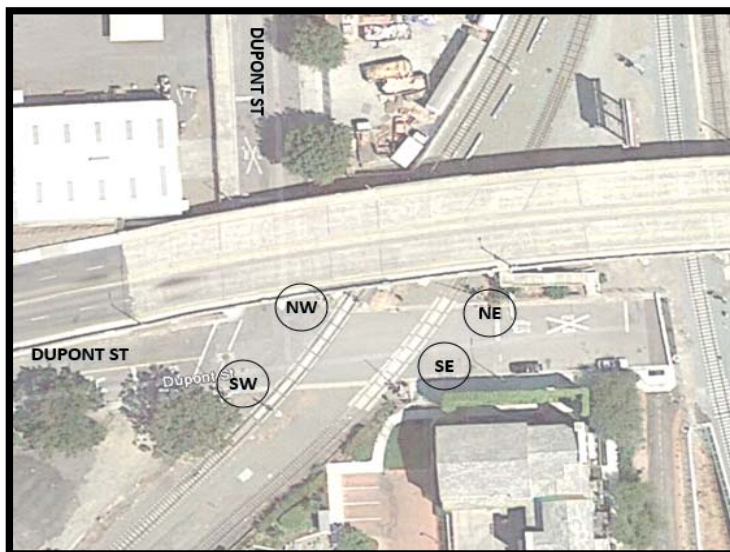
DUPONT ST

Comments	Response
<i>General</i>	
1 Crash History 2007 - 2019: none	n/a - informational comment
2 Land Uses: trail and residential multifamily at southeast quadrant; residential multifamily developments proposed at southwest and northwest quadrants	n/a - informational comment
3 This crossing is a good candidate for closure to regular vehicular traffic on the east leg since it dead-ends	Placement of a barricade along the west side of the tracks with 8.5' side clearance from the track was evaluated and deemed infeasible because the eastbound left turn movement overlaps with the rail envelope.
4 This is a 4-quadrant gate system without vehicle presence detection; current CPUC standard is to have vehicle presence detection; if any electrical alterations were made to this system, CPUC would require vehicle presence detection to be incorporated	n/a - informational comment
5 While diagnostic review was being conducted, a bicyclist ignored activated warning devices and rode through the crossing	n/a - informational comment

<i>SE quadrant</i>	
6 There is no sidewalk in between the tracks on the south side of the street; this leads pedestrians to enter the roadway in order to cross the tracks; connect the sidewalk over the tracks to keep pedestrians on the sidewalk	City staff and VTA are coordinating to seek developer contributions towards sidewalk and pedestrian treatments as part of the proposed developments on the southwest quadrant of the crossing.
7 The gate is missing bells and missing flashers facing eastbound	See Dupont Comment Response #6. Addition of bells and flashers could be incorporated into the improvements.
8 Signage ineffective – doesn't tell pedestrian what they need to do – there is no channelization	See Dupont Comment Response #6.
<i>NE quadrant</i>

9	There is a staircase connecting Dupont St with the San Carlos St Bridge; there is no sidewalk on the north side of Dupont St, and the staircase offloads pedestrians into the roadway; there is no channelization for pedestrians headed across the tracks; improve	See Dupont Comment Response #6 for planned improvements. In the longer term, the Diridon Station Integrated Concept Plan is a joint planning effort by City of San Jose, VTA, CA High Speed Rail Authority, and Caltrain to redesign Diridon station. On December 3, 2019, San Jose City Council endorsed the plan's recommended spatial layout of the station, which includes elevating the station. The raised station requires removal of the San Carlos Street Bridge and staircase, and a complete redesign of the Dupont Street crossing.
10	There is a chain link fence along the north edge of Dupont St at this quadrant; the fence is obstructing view of the warning signs; remove fence or push it north away from roadway	Caltrain placed the fence there temporarily during a construction project. The fence has been removed.

<i>NW quadrant</i>		
11	Gate is missing flashers facing east, and missing bells Gate does not meet current MUTCD standard clearance	Comment for VTA. Also see Dupont Comment Response #9.
12	requirement of 4'3" between the center of the pole and the face of curb	Comment for VTA. Also see Dupont Comment Response #9.
13	Gate does not meet current standard clearance required between the counterweight and the bridge pier	Comment for VTA. Also see Dupont Comment Response #9.
14	Roadway appears to be recently paved; verify required striping is put in place	Required pavement markings were recently installed (Fall 2019) on the north and west legs.
15	Need W-48CA (2 Tracks) underneath the W10-4	See proposed signage and striping plans in Attachment K. This sign will be added.
<i>SW quadrant</i>		
16	Check height of flashers – appears low	Comment for VTA.
17	Check pole clearance to face of curb	Comment for VTA. Also see Dupont Comment Response #9.

18	Especially because of the track skew, future development on the private property at this corner should maximize pedestrian line of sight down the tracks to see oncoming trains	City staff will carry this comment through the development review cycle for the proposed development adjacent to the southwest quadrant of the crossing. The latest plan submittal for the development shows the northeast corner of the proposed building setback approximately 35' west from the nearest track and 40' south from the existing face of curb.
19	Visibility – Trees	The existing trees at the northeast corner of the lot adjacent to the rail corridor will be removed by the proposed development. We will also ensure that the development does not place trees or other obstacles near the crossing that would obstruct line of sight down the rail corridor.

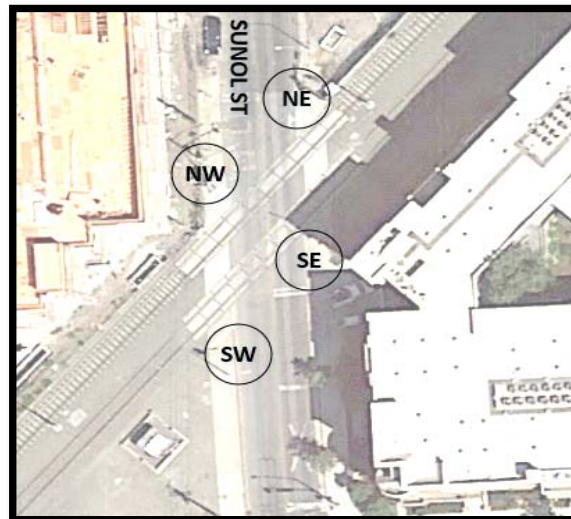
SUNOL ST

Comments	Response
<i>General</i>	
<p>Crash History 2007 - 2019:</p> <ul style="list-style-type: none"> • 3/12/13 Injury: southbound pedestrian in northeast quadrant hit by northbound LRT; pedestrian suffered injuries when pedestrian entered crossing against activated warning devices and was struck by the LRT • 6/8/13 Fatality: southbound bicyclist in northwest quadrant hit by northbound LRT; bicyclist rode into crossing against activated warning devices and was struck and killed by LRT 	n/a - informational comment
<p>Land Uses: This area used to be industrial; now high density residential and a nearby park, which will generate more pedestrian traffic</p>	n/a - informational comment
<p>Adjacent developments and anticipated pedestrian traffic warrant full pedestrian treatments (automated pedestrian gate, pedestrian swing gate, channelization, and detectable warning strip) at all quadrants</p>	See Attachment L for proposed gates. Pedestrian treatments at all quadrants are proposed.

<p>History: There were a few meetings at Sunol and Auzerais crossings in the past to improve the crossing with the new development; VTA, CPUC, and construction inspectors from CSJ attended; developer always disappeared following CPUC and VTA comments; CSJ needs a process to condition upgrades to crossings in planning phase of developments; recently, CSJ obtained \$1M from the developer to use towards improvements at the Sunol and/or Auzerais crossings; CSJ is coordinating with VTA to have VTA construct comprehensive improvements as part of their Pedestrian Back Gates Project and be reimbursed by CSJ</p>	See General Comment Response #14.
<p>4 quadrant gate system is the only SSM available due to driveways</p>	See Attachment L for proposed gates. A 4-quadrant gate system is proposed.
<i>SE quadrant</i>	
<p>Refresh pavement markings for northbound direction</p>	See proposed signage and striping plans in Attachment K. These pavement markings will be refreshed.

7	NB stop bar doesn't appear compliant; new requirement is a single 24" wide bar	See proposed signage and striping plans in Attachment K. This stop bar will be replaced.
8	There is a driveway that appears to just serve trash collection; this is a bad location just south of the crossing because trash collection vehicles can block traffic's view of the crossing; some vehicles could circumvent the trash collection vehicle and enter the rail crossing when trains are approaching; close this driveway or install a 4-quadrant gate system to mitigate this risk	We reached out to the Monte Vista property management and HOA and offered to close the driveway at no cost to them. They considered it but ultimately decided not to close the driveway because of concerns with using another driveway for trash collection.
9	Remove the two trees on the sidewalk on the east side of Sunol, south of the crossing; these trees block view of the crossing warning devices	The trees in question are juvenile specimens. At maturity, these trees will have a height of over sixty feet and will allow the crown to be maintained at our standard fourteen feet over the roadway to provide adequate clearance for larger vehicles and should not present a long term issue for visibility at the crossing. In the interim, these trees have been raised to between eight and ten feet to provide visibility of the warning signs and devices. This will likely stimulate additional upward growth at the top and allow for a more permanent clearance pruning in 2-3 years.

<i>NE quadrant</i>		
10	Remove "No Left Turn" sign facing northbound traffic since there is no longer a driveway to turn into	See proposed signage and striping plans in Attachment K. This sign will be removed.
11	The slatted fence along the rail corridor blocks views for southbound traffic of trains coming from the north; remove or replace with a fence that doesn't block visibility	Comment for VTA.
12	Remove the nonstandard "No Train Horn" sign that is mounted on the streetlight pole	See proposed signage and striping plans in Attachment K. This sign will be removed.
13	There is an Emergency Vehicle Access driveway within 60 feet of the crossing; this is problematic because vehicles using this driveway can cause downstream traffic to queue over the tracks	See Attachment L for proposed gates. A 4-quadrant gate system is proposed.
<i>NW quadrant</i>		
14	Replace defective gate arm (immediate action item unrelated to quiet diagnostic meeting)	VTA replaced the defective gate arm immediately after the diagnostic meeting.

15	Missing required warning signage and pavement markings; install immediately	RXR pavement marking has since been installed. A missing W48(CA) sign will be installed (Attachment K).
16	There is no ADA path to the crossing- create an ADA path approaching and into the crossing	See Attachment L for proposed gates. Pedestrian treatments, including expanded sidewalk, are proposed.
17	What type of wall is the developer installing along the rail corridor? It should allow visibility of the rail corridor	The developer installed a chain link fence; it allows for visibility between the sidewalks and rail corridor
18	Is the lower traffic signal head mounted at a compliant height? Appears very low	We reviewed all locations where there is a pole-mounted traffic signal head at a low height over the sidewalk (Sunol, Race, Parkmoor, Fruitdale, Leigh, Stokes). These supplemental signal faces provide extra visibility for drivers of the pre-signal indication. After the striping and signage plans and other planned improvements are implemented, we will evaluate whether these signal heads still provide a benefit or should be removed.

19	Why is there a bollard in the middle of the sidewalk; can it be removed	See Sunol Comment Response #18. The bollard channelizes pedestrians away from walking into the pole-mounted traffic signal head. If City staff determine that this signal head should be removed after improvements are completed, the bollard will be removed with it.
20	Installing complete pedestrian treatments might require relocating the Commission Standard #9 gate closer to the roadway in order to have room behind for the pedestrian treatments	n/a - informational comment
<i>SW quadrant</i>		
21	Fence off all sides of the triangular parcel at the northwest corner of the Auzeais/Sunol intersection to prevent trespassing onto the rail corridor and to help channelize pedestrians to the pedestrian crossings	The adjacent developer is preparing a proposal for improving this triangular parcel. We asked the developer to include channelization elements that deter trespassing.

22	Ensure that the sidewalk approach matches up with recommended widened sidewalk coming from the other side of the tracks	See Attachment L for proposed gates. Pedestrian treatments, including expanded sidewalk, are proposed.

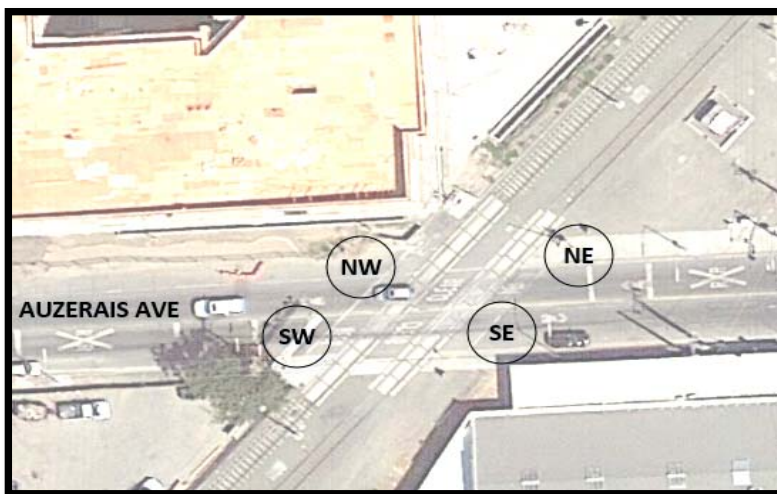
AUZERAIS AVE

Comments	Response
<i>General</i>	
1 Crash History 2007 - 2019: none	n/a - informational comment
2 Land Uses: This area used to be industrial; now it is under construction for high density residential and there is a nearby park, which will generate more pedestrian traffic	n/a - informational comment
3 Adjacent developments and anticipated pedestrian traffic warrant full pedestrian treatments (automated pedestrian gate, pedestrian EXIT swing gate, channelization, and detectable warning strip) at both quadrants on the north side	See Attachment L for proposed gates. Pedestrian treatments are proposed on the north side, but not the south side because of the sidewalk gap. The City would seek new sidewalk and pedestrian treatments on the south side as part of future development applications on the adjacent parcels.
4 Refresh pavement markings (Keep Clear, stop bar, etc.) and ensure up to current standard	See proposed signage and striping plans in Attachment K. Pavement markings, especially stop bars and crosswalks, will be updated to current standard. Faded pavement markings will be refreshed.

5 History: There were a few meetings at Sunol and Auzerais crossings in the past to improve the crossing with the new development; VTA, CPUC, and construction inspectors from City of San Jose attended; developer always disappeared following CPUC and VTA comments; CSJ needs a process to condition upgrades to crossings in planning phase of developments; recently, CSJ obtained \$1M from the developer to use towards improvements at the Sunol and/or Auzerais crossings; CSJ is coordinating with VTA to have VTA construct comprehensive improvements as part of their Pedestrian Back Gates Project and be reimbursed by CSJ	See General Comment Response #14.
6 Proper pedestrian channelization is missing	See Auzerais Comment Response #3.
7 ADA access needs to be addressed	See Attachments K and L. The proposal is to keep pedestrians on the north side of Auzerais between Lincoln Ave and Sunol St. DOT will connect the existing sidewalk gap on the north side of Auzerais to the west of the crossing using striping.

8	Fence off all sides of the triangular parcel at the northwest corner of the Auzerais/Sunol intersection to prevent trespassing onto the rail corridor and to help channelize pedestrians to the pedestrian crossings	The adjacent developer is preparing a proposal for improving this triangular parcel. We asked the developer to include channelization elements that deter trespassing.
---	--	--

9	There is a gate arm for a driveway that used to exist but was removed with the new development; the driveway gate extended into the roadway as well, functioning as a quasi-exit gate the developer wanted to remove the gate arm, and met with CPUC and VTA; CPUC wanted the developer to install pedestrian treatments as part of the work; the developer disappeared; City and VTA are coordinating on comprehensive improvements at this crossing as part of VTA's Pedestrian Back Gates project	A GO88b was issued to CPUC and CPUC provided approval to remove the gate arm. VTA has a contractor on board who is working on the programming that needs to be adjusted before the obsolete gate arm can be removed.
---	--	--

10	VTA recently determined that this third gate arm is a pedestrian collision hazard; the gate comes down 7 seconds after the other gates (to allow westbound vehicles to clear the crossing; with the new sidewalk installed, eastbound pedestrians are channelized towards this quadrant and could enter the crossing and get trapped on the tracks by the lowered gate; VTA and the developer have installed barricades on the sidewalk to deter pedestrians from crossing here; City and VTA are coordinating on a GO88 to remove the remnant gate arm in the near-term and re-open the sidewalk	See Auzerais Comment Response #9.
----	---	-----------------------------------

11	Replace W10-9P with the standard size consistent with your other locations	See proposed signage and striping plans in Attachment K. This sign will be replaced.
12	There is a tree on the private property side of the fence which is blocking visibility of the crossing warning devices and appears to be in contact with overhead electrical lines; remove this tree or trim it down substantially	This tree will be removed.
13	Remove "Road Construction Ahead" sign mounted on the PG&E pole if it is no longer needed	See proposed signage and striping plans in Attachment K. This sign will be removed.
14	The private property adjacent to this quadrant has a driveway cut; this driveway is too close to the crossing; close the driveway and replace with sidewalk and curb	The owner has agreed to let the City close the two existing driveways on the southwest quadrant of the crossing and install one new driveway at the west edge of the property approximately 120 feet away from the gate arm. See Attachment K.

15	prohibit parking on the curb all the way to the crossing from the property's other driveway	See proposed signage and striping plans in Attachment K. This curb will be painted red.
16	check distance that warning signs are placed relative to crossing	Warning signs are located approximately 90 feet from the stop bar which is consistent with CA MUTCD Table 2C.4 guideline of 100 feet advance placement distance for a street with a 25 mph speed limit.

| 17 | add a No Sidewalk barricade at an appropriate location between this quadrant and Lincoln Ave | See proposed signage and striping plans in Attachment K. Signs are proposed at Lincoln Ave and at Sunol St to direct pedestrians to use the north side of Auzeais Ave. |

| 18 | add a No Sidewalk barricade between this quadrant and Sunol St.

CPUC recommends the barricade be installed at the Sunol and Auzeais intersection | See Auzeais Comment Response #17. |

| 19 | red curb from intersection to crossing | See Auzeais Comment Response #15. |

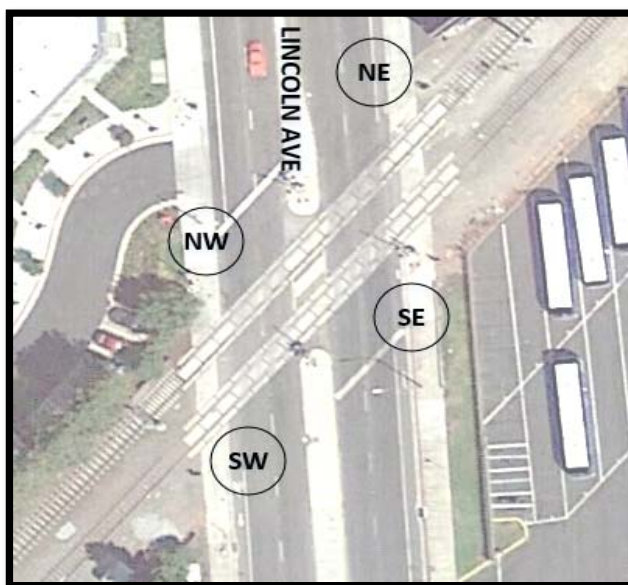
LINCOLN AVE

Comments	Response
<i>General</i>	
<p>1 Crash History 2007 - 2019:</p> <ul style="list-style-type: none"> • 7/8/18 Double Fatality: driver of vehicle ignored activated warning devices, drove vehicle through gate arms and was struck by LRT, killing both the driver and the passenger of the vehicle 	n/a - informational comment
<p>2 Land Uses: multifamily residential, medical, industrial, commercial</p>	n/a - informational comment
<p>3 Driveways to adjacent properties are too close to crossings</p>	<p>The City is working with the property management to close the driveway at the northeast quadrant pending agreement from tenants and Fire Department, and a new parking site plan. If the driveway cannot be closed, City will request that it be marked right-out, exit-only.</p>
<p>4 Any access to adjacent properties that is 60 feet or less from the crossing needs to be eliminated</p>	<p>See Lincoln Comment Response #3. Our quiet zone application proposes a partial risk reduction for the ASM at this crossing due to the driveways.</p>

<p>5 A 4-quadrant gate system would be ideal here because of the cars driving at higher speeds, because of the adjacent driveways on both north quadrants, and because of the adjacent alcoholic establishment</p>	See Lincoln Comment Response #4.
<p>6 Pedestrian gates not prioritized at this location as it does not appear to have high pedestrian flows</p>	n/a - informational comment
<p>7 While diagnostic review was being conducted, a bicyclist ignored warning devices signaling a train was coming and went through the crossing as arm gates were coming down</p>	n/a - informational comment
<i>SE quadrant</i>	
<p>8 change W10-9P sign to our current standard</p>	<p>See proposed signage and striping plans in Attachment K. This sign will be replaced.</p>
<p>9 relocate bus stop and bus stop sign</p>	<p>VTA removed this bus line in December 2019 as part of a new transit service place.</p>

10	gate on sidewalk is missing flashers facing north	Comment for VTA.
11	the gate in the sidewalk and the warning signs crowd the sidewalk and could lead to pedestrians walking behind the sidewalk around the control devices; suggest relocating warning signs and adding pedestrian channelization	See proposed signage and striping plans in Attachment K. The R15-8 sign will be removed.
12	warning signs look big; check dimensions	See proposed signage and striping plans in Attachment K. The R15-8 sign will be removed. The W82-1(CA) and W10-9P signs conform to CA MUTCD size requirements.
<i>NE quadrant</i>		
13	the adjacent plaza has 3 driveways on Lincoln and one driveway on Auzerais; the driveway just north of the crossing is located very close to the tracks and raises the risk of a vehicle driving in opposing traffic across the tracks; also, the establishment in the plaza that is closest to the tracks is an alcoholic establishment; close this driveway if possible	See Lincoln Comment Response #3.

14	if the driveway cannot be closed, add a median mounted "Right Turn Only" sign, stripe the driveway as a right turn out only, add edge lines in the driveway to guide vehicles to turn right out, and modify the driveway to physically force vehicles to turn right as they exit	If the driveway cannot be closed, City will request that it be marked right-out, exit-only, and City will evaluate locating a "Right Turn Only" sign in the median.
<i>NW quadrant</i>		
15	check W10-9P sign for consistency	See proposed signage and striping plans in Attachment K. This sign will be replaced.
16	the residential development should not have been allowed to locate the driveway within proximity of the tracks	See General Comment Response #14.
17	check ADA compliance around gates	This crossing in general was not considered to have high pedestrian volumes and thus was not prioritized for pedestrian treatments.
18	widen the sidewalk to the back to open up an ADA path for pedestrians around the gate	See Lincoln Comment Response #17.

19	the tree right next to the gate is overgrown and blocking visibility of the warning devices; remove it or trim it back considerably and maintain regularly	The City will trim this tree, or follow up with the property management for tree trimming.
20	warning signs look big; check dimensions	See proposed signage and striping plans in Attachment K. The R15-8 sign will be removed. The W82-1(CA) and W10-9P signs conform to CA MUTCD size requirements.
21	gate is missing flashers facing south	Comment for VTA.
<i>SW quadrant</i>		
22	the visibility between this quadrant and the rail corridor is limited because of the tracks skew and trees lining the rail corridor; flashers and bells are needed at this quadrant	Comment for VTA. VTA is considering pedestrian treatments here as part of their Pedestrian Back Gates project.

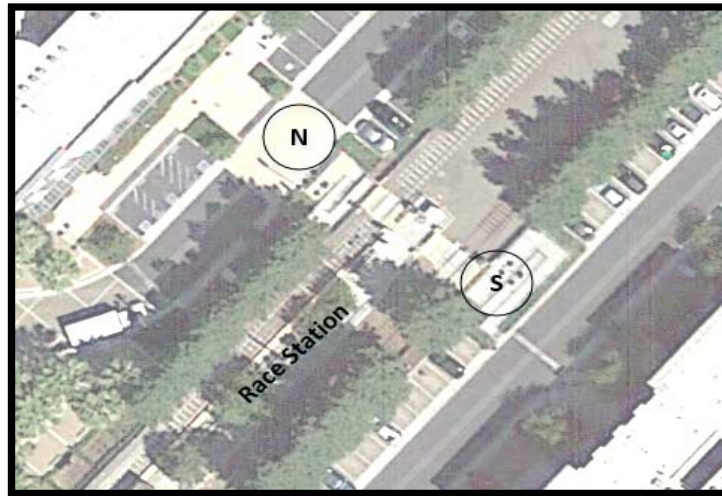
RACE STATION

Comments	Response
<i>General</i>	
1 Crash History 2007 - 2019: none	n/a - informational comment
2 Land Uses: high density residential both sides	n/a - informational comment
3 Detectable warning strips should be outside of the gates; currently they are inside the gates which can give the wrong impression to a vision-impaired user that they are within a "safe zone"	Comment for VTA.
4 The north side of the crossing doesn't have flashers positioned in advance of the gates; Install Commission Standard #8 flasher	Comment for VTA.

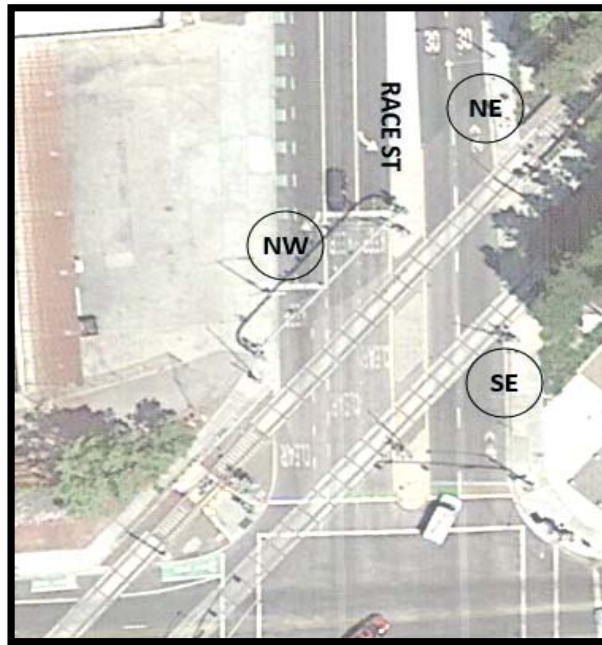
RACE ST

Comments	Response
<i>General</i>	
<p>1 Crash History 2007 - 2019: •2/4/12 Injury: pedestrian suffered injuries when pedestrian entered the crossing while the warning devices were activated and was struck by LRT</p>	<p>n/a - informational comment</p>
<p>2 Land Uses: high density residential and Light Rail station on east side; proposed school with 2700 students on west side; a recently opened school resides on the opposite corner (SE) on the Race and Parkmoor intersection</p>	<p>n/a - informational comment</p>
<p>3 The property on the west side of Race St is proposed for redevelopment into a school of 2700 students; CSJ's conditions on the property redevelopment require the school to utilize crossing guards during school drop off and pick up, to conduct at least annual crossing safety trainings</p>	<p>n/a - informational comment</p>
<p>4 Loading zones, school buses, etc. should be located as far away from the tracks as possible</p>	<p>City staff will carry this comment through the development review cycle for the proposed development on the northwest corner of Race/Parkmoor. The latest plan submittal for the development shows an ingress only driveway on Race St approximately 400 feet north (upstream) of the tracks, and an egress-only driveway on Parkmoor approximately 200 feet west (downstream) of the tracks.</p>

<p>5 City of San Jose Traffic Safety Education Officer, Cordell Bailey, performs frequent trainings at schools in San Jose and will do so at this school after it opens; he is Operation Lifesaver certified</p>	<p>n/a - informational comment</p>
<p>6 This crossing overlaps with the Parkmoor crossing</p>	<p>n/a - informational comment</p>
<p>7 Pedestrian treatments suggested at all quadrants</p>	<p>See Attachment L for proposed gates. Pedestrian treatments at all quadrants are proposed.</p>

8	<p>FRA is concerned with these two crossings (Race & Parkmoor); track and intersection geometry is very challenging to mitigate; multiple collisions, especially at the northwest corner of the Race/Parkmoor intersection; existing school on the southeast corner of the intersection; and now a school going to open on the northwest corner of the intersection. This would be an ideal candidate for grade-separation of the light rail track (e.g. see LRT flyover at Hamilton Ave in San Jose).</p>	<p>The City developed a new plan line for Race St and Parkmoor Ave to improve this location. See Attachment L.</p>
9	<p>Per CPUC, this location would be an ideal candidate for a pedestrian overcrossing.</p>	<p>A pedestrian overcrossing is not preferred because it would require pedestrians to take a longer and less direct path and, is not expected to achieve high compliance at this location. Instead, this crossing will be reconstructed to improve safety for all users at-grade. See Attachment L.</p>

10	<p>FRA prepared a concept for a redesign of the intersection and crossings that they would like to share with the group</p>	<p>City obtained the concept from FRA. The concept relocates the north leg and west leg crosswalks to the north and west sides of the tracks, respectively. This was one of two concepts that City staff evaluated. City staff determined that in order for the crosswalks to operate safely and be protected from right-turning drivers, they would need to be signalized and have an exclusive pedestrian phase coinciding with an all-red for the rest of the intersection. City staff determined that this would yield an unacceptable impact on operations, noting that the signal already experiences all-red over 160 times per day with each LRT movement through the intersection. This type of impact would be expected to result in driver frustration and violations of the signals, which would put pedestrians at more risk. Instead, this crossing will be reconstructed per the concept in Attachment L.</p>

11	<p>City of San Jose geometrics team has prepared some concepts for a redesign of the intersection and crossings that we will share with the group after they have gone through internal city review</p>	<p>See Attachment L. This concept has been coordinated with FRA, VTA, and CPUC. The City will continue to coordinate the design with the stakeholders as it progresses.</p>
12	<p>Suggest adding a controlled crosswalk mid block north of the tracks and a minimum of 200 feet away the crossing to enable students/pedestrians to cross Race St between the school side and the LRT station side without having to cross the tracks</p>	<p>See Attachment L. City staff considered a mid block crosswalk on Race St north of the crossing, but ruled it out for safety reasons due to the three back-to-back left-turn pockets.</p>
13	<p>Overall, FRA understands that there are efforts underway to improve the crossing (proposed improvements to be conditioned on school development, CSJ geometrics team evaluating intersection reconfiguration options), and requests CSJ engage FRA and CPUC in that ongoing work</p>	<p>See Race Comment Response #11.</p>

14	<p>Median dividing northwest and northeast quadrants does not meet curb height requirements</p>	<p>The City of San Jose will add channelizers onto the median islands in the near term. In the long term, the median islands will be reconstructed to a minimum 8" height as part of the proposed development on the northwest corner of Race/Parkmoor.</p>

15	Gate does not meet current MUTCD standard clearance required between the center of the pole and the face of curb	See Attachment L. This gate arm would likely be replaced.
----	--	---

17	Southbound vehicles on Race often miss the stop bar for the pre-signal; need to refresh pavement markings; check if signage, pavement markings, etc. can be modified to yield higher driver compliance. Possible candidate to install crosshatch pavement markings.	See proposed signage and striping plans in Attachment K. In the near-term, the stop bar will be relocated and signal heads will be evaluated.
----	---	---

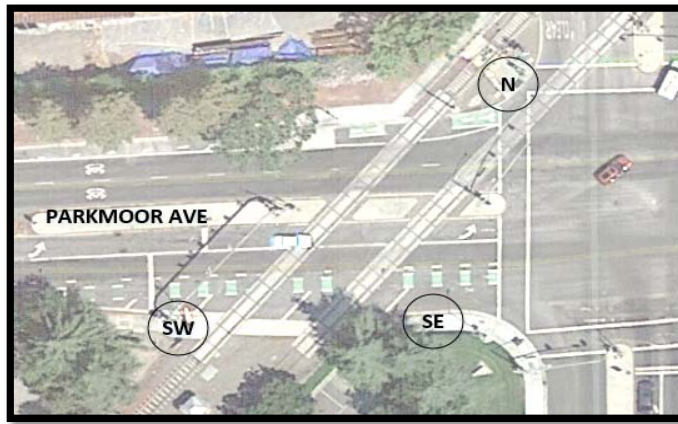
PARKMOOR AVE

<p>3 Overall, FRA understands that there are efforts underway to improve the crossing (proposed improvements to be conditioned on school development, CSJ geometrics team evaluating intersection reconfiguration options), and requests CSJ engage FRA and CPUC in that ongoing work.</p>	<p>See Attachment L. This concept has been coordinated with FRA, VTA, and CPUC. The City will continue to coordinate the design with the stakeholders as it progresses.</p>
--	---

6	Can Sheriff or Police do more enforcement of violations?	County police perform regular sting operations at this location.
7	While diagnostic review was occurring, an individual in a wheelchair traveling southbound on Parkmoor across Race Street ignored crosswalk path and traveled parallel with the road. Suggest re-channeling pedestrians through this crosswalk.	See Attachment L for the proposed improvements.
<i>SE quadrant</i>		
8	Add Commission Standard #8 flasher to this quadrant as a near-side warning device for pedestrians approaching the crossing	See Attachment L for the proposed improvements.
9	Extend the chain link fence that runs along the rail corridor all the way to the back of sidewalk	This will be incorporated into the proposed improvements (Attachment L) as that design progresses.
10	Add a fence along the back of sidewalk between the intersection and the crossing to channelize pedestrians.	This will be considered with the proposed improvements (Attachment L).

<i>SW quadrant</i>		
11	Standardize signage	See proposed signage and striping plans in Attachment K.

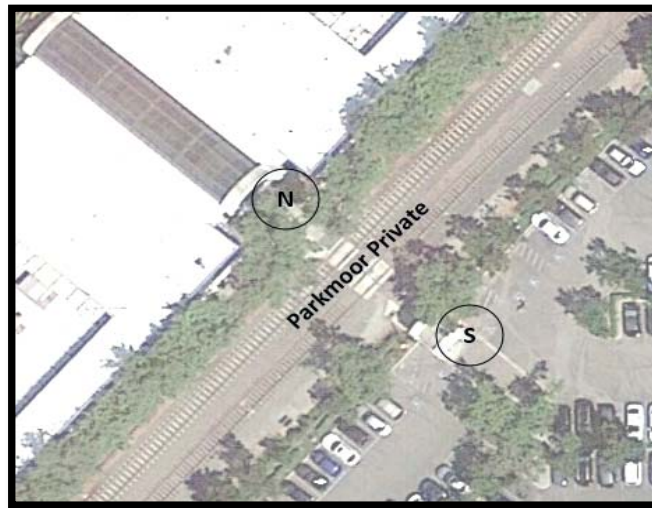
PARKMOOR PEDESTRIAN

Comments	Response
<i>General</i>	
1 Crash History 2007 - 2019: none	n/a - informational comment
2 Land Uses: office building to the north and associated parking lot to the south	n/a - informational comment
3 Current swing gates are chain link and camouflage with the fence; convert to VTA standard swing gate	Comment for VTA.
4 There are multiple surfaces across the tracks (asphalt, ballast, concrete); repave to make one, consistent smooth surface (e.g. see Fruitdale Station); refresh paint for edge lines that line the crossing over the tracks	Comment for VTA.

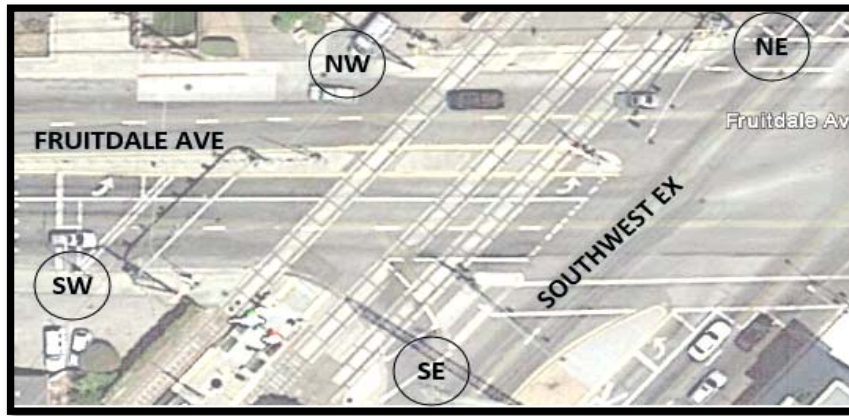
FRUITDALE AVE

Comments	Response
<i>General</i>	
<p>1 Crash History 2007 - 2019: •10/5/18 Injury: pedestrian suffered injuries when pedestrian ignored activated warning devices and was hit by LRT in quadrant</p>	<p>n/a - informational comment</p>
<p>2 Land Uses: multifamily residential all quadrants; LRT station to the south</p>	<p>n/a - informational comment</p>
<p>3 Lots of disabled and medical patients and emergency vehicles pass through this crossing from the Valley Medical Center one mile to the east</p>	<p>n/a - informational comment</p>
<p>4 Do crossings have power off indicators? VTA: they have live monitoring from OCC</p>	<p>n/a - informational comment</p>
<p>5 Dynamic Message Signs “No Right Turn” should be upgraded to the current R3-1 Activated Blank Out Sign standard with the next modification to this crossing’s electrical devices</p>	<p>n/a - informational comment</p>
<p>6 There is an LRT station very close to this crossing; there is a pedestrian barricade along the median island to discourage jaywalking across Fruitdale; however there is no crosswalk on the west leg of the intersection; wonder if these conditions are encouraging pedestrians to cross Fruitdale by walking along the tracks (rather than using 3 crosswalks at the intersection); how can we improve it</p>	<p>See proposed signage and striping plans in Attachment K. A crosswalk on the west leg of Southwest Ex/Fruitdale Ave intersection could not be accommodated in the design and construction of the Vasona LRT corridor due to the proximity of the tracks to the intersection. While DOT does not recommend uncontrolled mid-block crosswalks across streets with 4 or more lanes, the pedestrian demand and non-compliance here triggered a more comprehensive analysis to provide a safe pedestrian crossing at this location. DOT will install a new enhanced crosswalk with bulb-outs, median refuge island, and rectangular rapid flashing beacons on Fruitdale Ave at College Dr, approximately 460 feet west of the tracks, to be implemented in 2020.</p>

<p>7 While diagnostic review was being conducted a truck and 2 cars became stuck between activated arm gates and intersection at both the Southeast and Northeast quadrants indicating the timing of the signals needs to be adjusted to allow vehicles to adequately clear the area</p>	<p>Track Clearance timing doesn't start after the gates are down, but before that, in order to let the vehicle to pass and clear the intersection. During the diagnostic review at this intersection, the timing settings for preemption events were checked and were found to be adequate. The preemption log was shown to FRA and CPUC representatives.</p>
<p>8 While diagnostic review was occurring, members of the team became caught between the light and the gate arm at the northwest and northeast quadrants indicating the timing of the signals needs to be adjusted to allow pedestrians to clear the area</p>	<p>Also, see proposed signage and striping plans in Attachment K. For the eastbound movement, the pre-signal stop bar will be relocated, the downstream stop bar eliminated, and Keep Clear pavement markings added at the tracks. These striping changes should reduce the amount of eastbound drivers crossing the tracks after the pre-signal turns red and track clearance is underway.</p>

19	This pedestrian gate is an old design; if upgraded, the new design should include a swing gate next to the automatic gate and channelization	n/a - informational comment
20	Warning signs are located very close to the sidewalk, partially obstruct sidewalk path	See proposed signage and striping plans in Attachment K. The R15-8 sign will be removed.
<i>SW quadrant</i>		
21	Change "No Train Horn" sign located under the W10-1 to standard dimension	See proposed signage and striping plans in Attachment K. This sign will be replaced.
22	Refresh pavement markings on EB Fruitdale	See proposed signage and striping plans in Attachment K.
23	"No Train Horn" and "Look Both Ways" warning signs mounted on sound wall are covered by ivy; relocate to pole mount	See proposed signage and striping plans in Attachment K. These signs will be relocated.

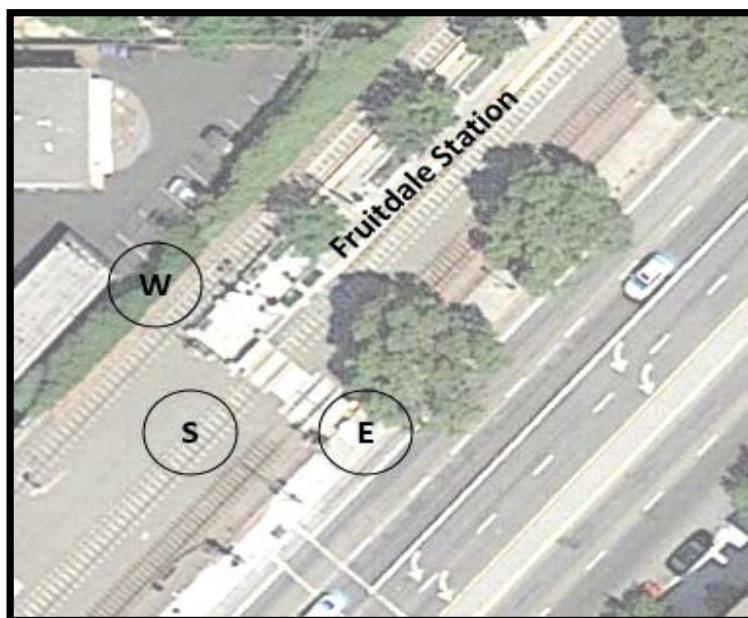
FRUITDALE STATION

Comments	Response
<i>General</i>	
Crash History 2007 - 2019:	
1 •6/26/09 Fatality: pedestrian ignored activated warning devices, went through push gate and was hit and killed by LRT	n/a - informational comment
2 Land Uses: multifamily residential	n/a - informational comment
3 Detectable warning strips should be outside of the gates; currently they are inside the gates which can give the wrong impression to a vision-impaired user that they are within a "safe zone"	Comment for VTA.
4 Standardize sign configuration and placement	Comment for VTA.
5 Move ENS to pole at dead-end of station platform; move No Trespassing sign from pole at dead-end to somewhere else	Comment for VTA.
6 Fix or maintain swing gates	Comment for VTA.
7 Refresh paint for edge lines that line the crossing over the tracks between the swing gates	Comment for VTA.
8 Relocate Look Both Ways sign from pole at dead-end of platform because peds can only exit to the left; also sign blocks visibility of oncoming trains	Comment for VTA.

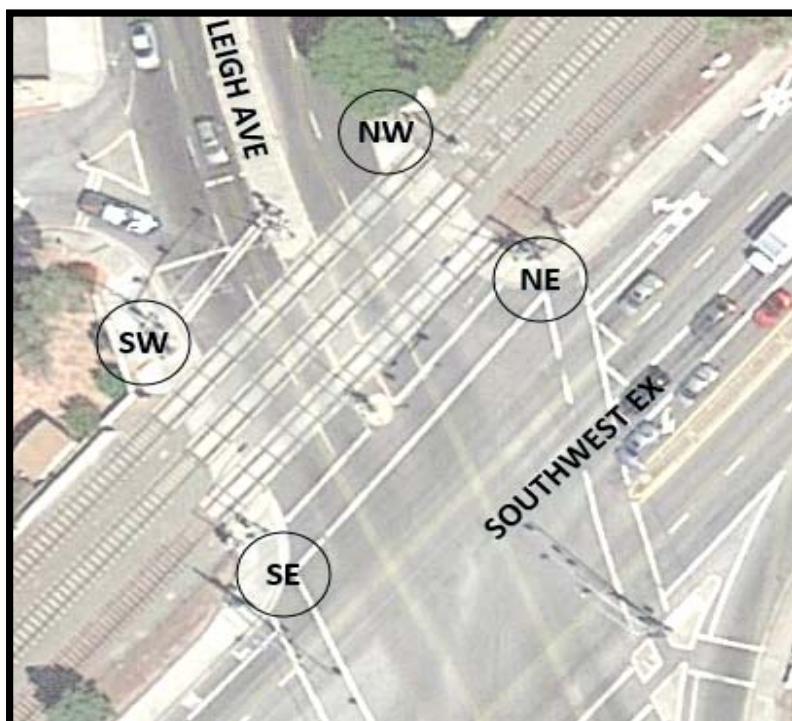
LEIGH AVE

Comments	Response
<i>General</i>	
<p>1 Crash History 2007 - 2019:</p> <ul style="list-style-type: none"> o 6/18/09 Fatality: pedestrian ignored activated warning devices, went around vehicular gate arm and was struck and killed by LRT o 1/2/11 Fatality: pedestrian ignored activated warning devices, ran across the tracks and was hit and killed by LRT 	<p>n/a - informational comment</p>
<p>2 Land Uses: residential, gas station, proposed commercial and senior housing</p>	<p>n/a - informational comment</p>
<p>3 This crossing is ideal for a 4-quadrant gate system because of the number of fatalities, the intersection with Cheney Dr very close to the crossing negating raised concrete median, and the high amount of traffic. The only location an exit gate could be installed in the NW quadrant is on the north median</p>	<p>This quiet zone application proposes a partial risk reduction for the ASM at this crossing due to Cheney Dr intersection. Vehicle exit gates were prioritized at other locations on the corridor.</p>

<i>SW quadrant (where Cheney intersects Leigh)</i>	
<p>4 On Cheney Dr, update W10-9P and place under W10-4; add W48 CA (3 Tracks) under W10-4; rotate W10-4 (Immediate action item)</p>	<p>See proposed signage and striping plans in Attachment K. These changes are reflected.</p>
<p>5 Remove W10-1 (since W10-4 is the appropriate sign here) (Immediate action item)</p>	<p>See proposed signage and striping plans in Attachment K. This sign will be removed.</p>
<p>6 Update W10-9Ps mounted on streetlight poles at crossing and at RXR pavement marking to standard size</p>	<p>See proposed signage and striping plans in Attachment K. These changes are reflected.</p>

21	Signal box blocks visibility between trains and sidewalk; ideally it would not have been placed here	The general comment that signal box location is important as it relates to visibility between the crossing and the rail corridor is noted and will be considered in design of new crossings and redesign of existing crossings.
22	There is a space between the signal box and the fence behind it; shrubbery obstructs view of it; this space should be maintained and monitored to prevent criminal activity or tampering with the crossing	Comment for VTA.
23	Trim the tree behind the signal box	Comment for VTA.
24	There is a No Trespassing sign on the fence behind the signal box; trim the foliage blocking the sign and also consider relocating the sign	Comment for VTA.
25	Remove the non-compliant No Train Horn sign and pole; there is already a (compliant) No Train Horn sign within 10 feet of it	See proposed signage and striping plans in Attachment K. This sign will be removed.

26	Relocate the bus stop which is located about 90 feet west of the crossing; stopped buses can cause vehicles to queue over the tracks	VTA removed this bus line in December 2019 as part of a new transit service place.

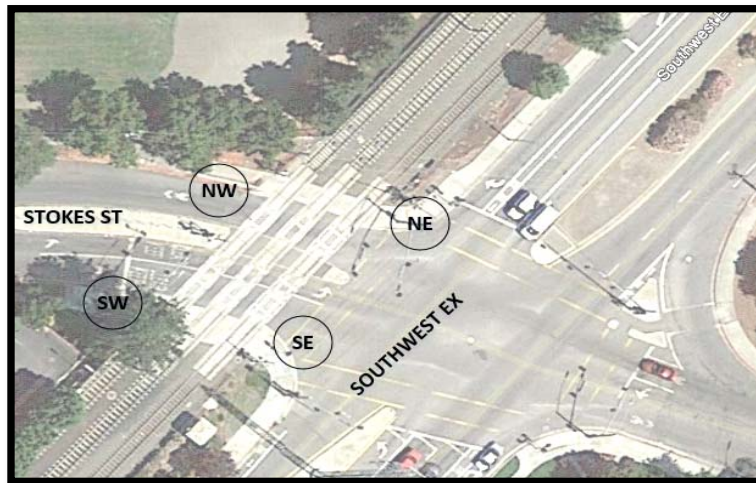
STOKES ST

1	<p>Crash History 2007 - 2019:</p> <ul style="list-style-type: none"> o 1/7/14 Fatality: bicyclist ignored activated warning devices, went around vehicular gate arm and was struck and killed by LRT o 6/22/14 Fatality: pedestrian ignored activated warning devices, went around gate and was struck and killed by LRT o 7/13/19 Injury: bicyclist suffered injuries when bicyclist ignored activated warning devices, went under vehicular gate arm and was struck by LRT 	n/a - informational comment
2	Land Uses: Del Mar High School, multifamily residential	n/a - informational comment
3	This crossing is packed in the morning with students	n/a - informational comment
4	VTA does regular crossing safety education for Del Mar High School	n/a - informational comment
5	FRA would like to participate in the education event	See Stokes Comment Response #6. FRA has been notified.
6	FRA suggests that the high school have two crossing safety trainings per year	Our traffic safety training officer, Cordell Bailey, provides hundreds of safety trainings at schools and centers in San Jose every year. He is Operation Lifesaver certified and is performing outreach at Stokes/Southwest Ex intersection adjacent to Del Mar High School and at Leigh/Southwest Ex in February 2020. His intention is to conduct outreach at the high school annually.

9	The traffic signal cycle seems long; long signal cycles encourage violations; check if it should be shortened	This intersection runs in free operations for a majority of the day, including the time of the field visit; this means that the cycle length is not fixed, but rather determined by the vehicular/pedestrian demand. The max length of each phase is capped at a relatively low amount of time. It may be possible that a preemption event caused what was perceived as a long cycle length for phases that conflict with the rail movement. The timing settings for preemption events were checked and were found to be adequate.
10	A passerby told us of his 20 years driving through this crossing and tending to a pedestrian fatality that he said happened because the signal box on the southeast quadrant blocked visibility	The general comment that signal box location is important as it relates to visibility between the crossing and the rail corridor is noted and will be considered in design of new crossings and redesign of existing crossings.

<i>SW quadrant</i>		
17	There is a fence between the rail corridor and the adjacent residential property; approximately the first fifty feet of the fence is tall and not-transparent; can this be shortened in height or replaced with a transparent fence to enhance visibility between the roadway/sidewalk and the rail corridor	Other improvements were prioritized at this location (see Attachments K and L).

22	There is a signal cabinet along the rail about thirty-five feet behind the sidewalk; Signal box blocks visibility between trains and sidewalk; ideally it would not have been placed here	The general comment that signal box location is important as it relates to visibility between the crossing and the rail corridor is noted and will be considered in design of new crossings and redesign of existing crossings.
<i>NE quadrant</i>		
23	Gate arm is too short; the tip should be a maximum of one foot from the median island (immediate action item for VTA to correct)	Comment for VTA.
24	Replace the damaged reflector on the median island (immediate action item for CSJ)	See proposed signage and striping plans in Attachment K. This is reflected.
25	Ideally there would be better pedestrian accommodation, including a wider refuge area here, pedestrian gates, and a wider paved area crossing the tracks	See Attachment L for proposed gates. Pedestrian treatments are proposed at all quadrants.

26	The problem with vehicular gates located behind the back of sidewalk is that once the arm comes down over the sidewalk pedestrian can become trapped on the tracks. There is no emergency path (like an EXIT swing gate) for a pedestrian in a crossing to exit from	See Attachment L for proposed gates. Pedestrian treatments are proposed at all quadrants.
27	Remove the W10-1; consolidate the W10-4, W48(CA), and W10-9P onto one pole	See proposed signage and striping plans in Attachment K. This is reflected.
<i>NW quadrant</i>		
28	Trim trees	Trees have been trimmed.
29	Pedestrian channelization looks good	n/a - informational comment

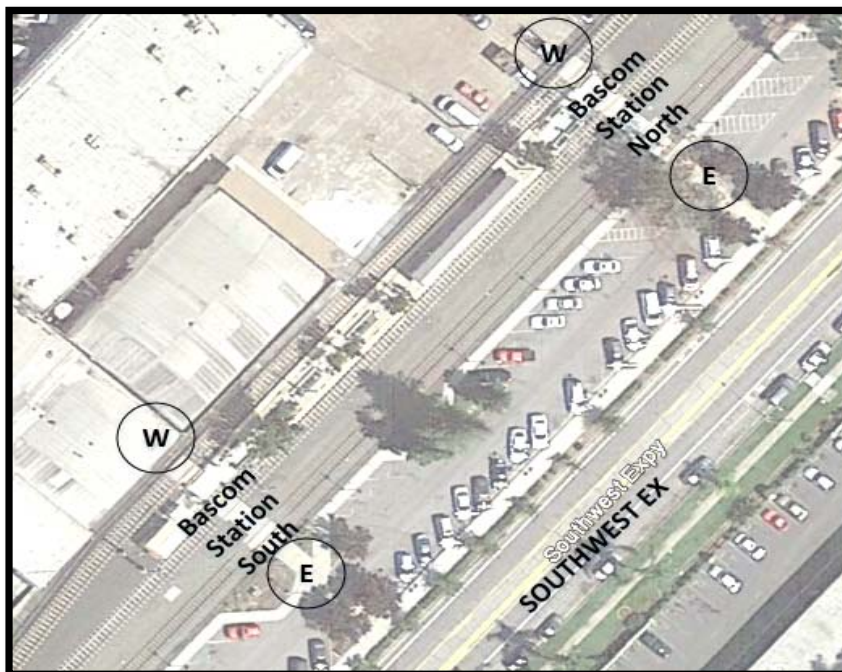
BASCOM STATION-NORTH & BASCOM STATION-SOUTH

Comments	Response
<i>General</i>	
1 Crash History 2007 - 2019: none	n/a - informational comment
2 Land Uses: multifamily residential; development proposed on the triangular parcel to the northwest of Bascom LRT Station will provide pedestrian access to both station entrances; the development includes 600 residential units, 300,000 square feet of commercial space, and a 200,000 square feet office building	n/a - informational comment
3 CPUC submitted a comment letter to City of San Jose Planning on 8/5 in which it recommended that the proposed development on the northwest quadrant: o Install Commission Standard 9 pedestrian automatic gates with EXIT swing gates and channelization at both pedestrian station crossings. o Relocate the detectable warning strips outside of the swing gates at the two pedestrian station crossings.	The developer must provide direct access to one or both station platforms from the development site per the City's permit conditions. The developer, City, and VTA have been in close coordination for two years, and the developer understands that they need to work with VTA and CPUC to modify the station crossing(s). The developer scheduled a field diagnostic with CPUC, VTA, and the City on 1/17/20.

4 Consider standard sign set up at all station crossings; perhaps move "Look Both Ways" and "No Train Horn" signs to swing gates	City is currently coordinating signage and striping plans with VTA.
5 Crossbuck signs on posts need to be rotated to face pedestrians coming from outside the crossing- rotate or add another crossbuck sign facing the nearest approach	Comment for VTA.
6 Replace signs damaged with graffiti (immediate action item)	Comment for VTA.
7 Swing gates need maintenance (immediate action item)	Comment for VTA.
8 Striping across tracks to delineate edge of pedestrian path needs to be refreshed	Comment for VTA.
9 Relocate detectable warning strips to outside of crossing	Comment for VTA.

12 There is a "Look Both Ways" sign in between the tracks; consider
removing, or relocate to swing gate Comment for VTA.

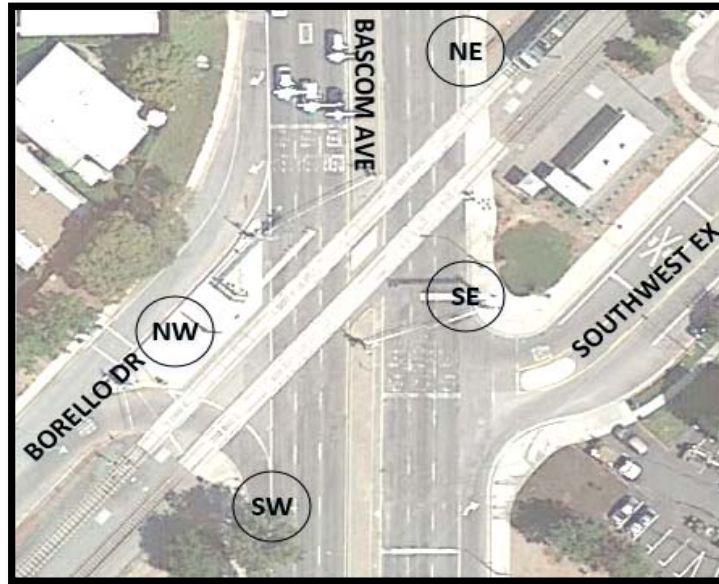
BASCOM AVE

Comments	Response
<i>General</i>	
<p>Crash History 2007 - 2019:</p> <p>1 • 3/10/17 Injury: pedestrian suffered injuries when pedestrian ignored activated warning devices and was struck by LRT</p>	<p>n/a - informational comment</p>
<p>2 Land Uses: residential; there is a development proposed adjacent to the northeast quadrant of the crossing; it includes 600 residential units, 300,000 square feet of commercial space, and a 200,000 square feet office building</p>	<p>n/a - informational comment</p>
<p>3 Big and awkward intersection</p>	<p>n/a - informational comment</p>
<p>4 CPUC submitted a comment letter to City of San Jose Planning on 8/5 in which it recommended that the proposed development on the northwest quadrant: Install Commission Standard 9 pedestrian automatic gates with EXIT swing gates and channelization on the sidewalk approaches at the South Bascom Ave crossing in the NE and SE quadrants</p>	<p>n/a - informational comment</p>

<p>5 Refresh pavement markings all approaches</p>	<p>See proposed signage and striping plans in Attachment K. Faded pavement markings will be refreshed.</p>
<p>6 This section is part of VTA's "Bascom Complete Streets" study</p>	<p>n/a - informational comment</p>
<p>7 While diagnostic review was occurring, a pedestrian ignored the activated warning devices and ran across the tracks, making it safely to the other side. When questioned as to why she ignored the warning devices she indicated that she had already started to cross. When questioned whether crossing arms or pedestrian gates would have stopped her from crossing she said yes...if she wasn't already in a hurry.</p>	<p>n/a - informational comment</p>
<i>SE quadrant</i>

8	Remove the young tree next to the "No Right Turn" LED sign on Southwest Ex; the tree blocks visibility of the crossing and will block visibility of the LED sign as it grows bigger (immediate action item for VTA)	Comment for VTA.
9	Signal box blocks visibility between trains and travel way; ideally it would not have been placed here	The general comment that signal box location is important as it relates to visibility between the crossing and the rail corridor is noted and will be considered in design of new crossings and redesign of existing crossings. Also, see Attachment L. Pedestrian treatments are proposed on all quadrants.
10	Full pedestrian treatments are warranted on the east side of Bascom because of the increased pedestrian traffic anticipated with the proposed development and because the signal box blocks visibility	See Attachment L for proposed gates. Pedestrian treatments are proposed at all quadrants.

11	There is a detectable warning strip located about 25 feet upstream of the track and 15 feet upstream of the flashers; this is too far from the crossing for pedestrian compliance and for visibility with the rail corridor; relocate closer to the crossing along with other pedestrian treatments recommended here	This will be incorporated into the proposed pedestrian treatments.
12	There is an informal pedestrian path that cuts across the triangular landscaping section between this quadrant and Southwest Ex; this path circumvents the advance warning devices (flashers); ensure any pedestrian treatments at this quadrant address this path as well	See Attachment L. This will be addressed as part of the proposed pedestrian treatments.
<i>NE quadrant</i>		
13	Recommend full pedestrian treatments to serve increased traffic anticipated with the new development and to match those treatments at the SE quadrant	See Attachment L for proposed gates. Pedestrian treatments are proposed at all quadrants.
