Memorandum

DATE: December 17, 2025

SUBJECT: Actions Related to the Emergency Repairs of Pond A18's Southern Gate Structure Located at the San José-Santa Clara Regional Wastewater Facility

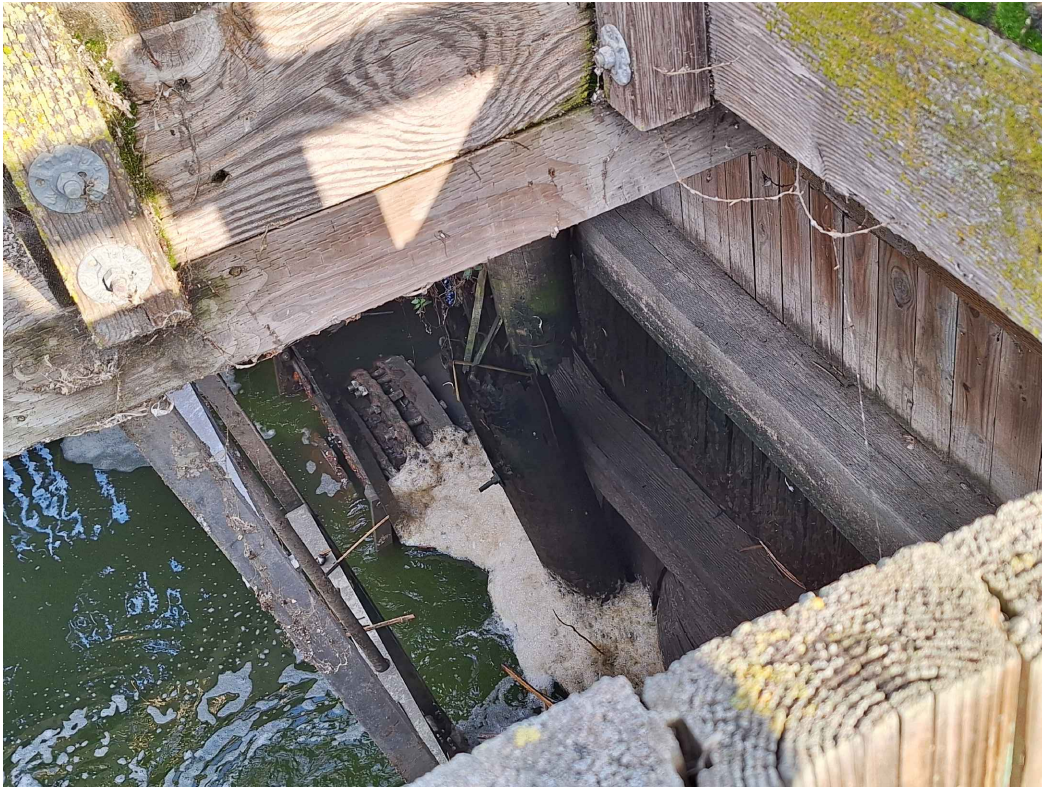
All three timber piles (12 inches in diameter, approximately the size of wooden utility poles) that support the headwall located on the slough side have failed below the normal tidal water level due to excessive horizontal loading. Significant bending, cracking and splitting of the piles and structure are visible. The horizontal timber supports that are visible above water are projected to worsen or fail completely as the horizontal loads increase due to consolidation and densification of backfill material. These failure modes are more closely linked to overstress rather than deterioration.

Significant underwater undermining and backfill loss has caused structural settlement and material loss above the waterline. This subsurface migration worsens with each tide and is intensified by turbulence and scour from water flowing through the twin 48-inch pipes. During recent visits on October 21, 2025, and November 24, 2025, the consultant reported that the north and center piles had ruptured, with their top halves completely separated from the bottom halves.

Photo: Center Pile (no. 2) is split

The three outer timber piles will be reinforced with stainless-steel sleeves installed 10 feet below the water. The upper sections of the center and northern piles will be removed, new casings placed and filled with concrete for strength and alignment. Damaged wooden planks and beams will be replaced. Steel piles, tied down with underground tie-rods and extra reinforcement, will stabilize the levee near the culverts and keep the restored timber piles in tension.

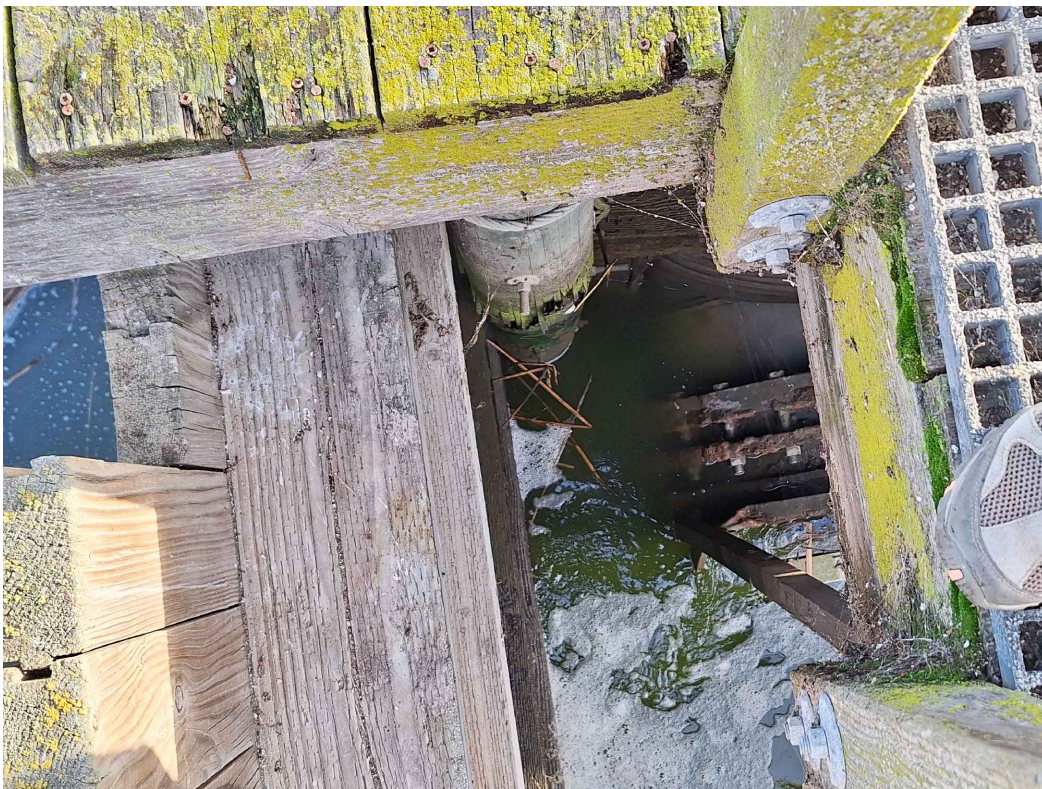
Photo: North Pile (no. 1) is cracked
