**SUBJECT: APPROVAL OF PARK MASTER
PLAN AT 3257 PAYNE AVENUE**

Approve the Master Plan for a 1.9-acre neighborhood park with phasing plan for a community center located at 3257 Payne Avenue.

MASTER PLAN REPORT

PAYNE AVE PARK

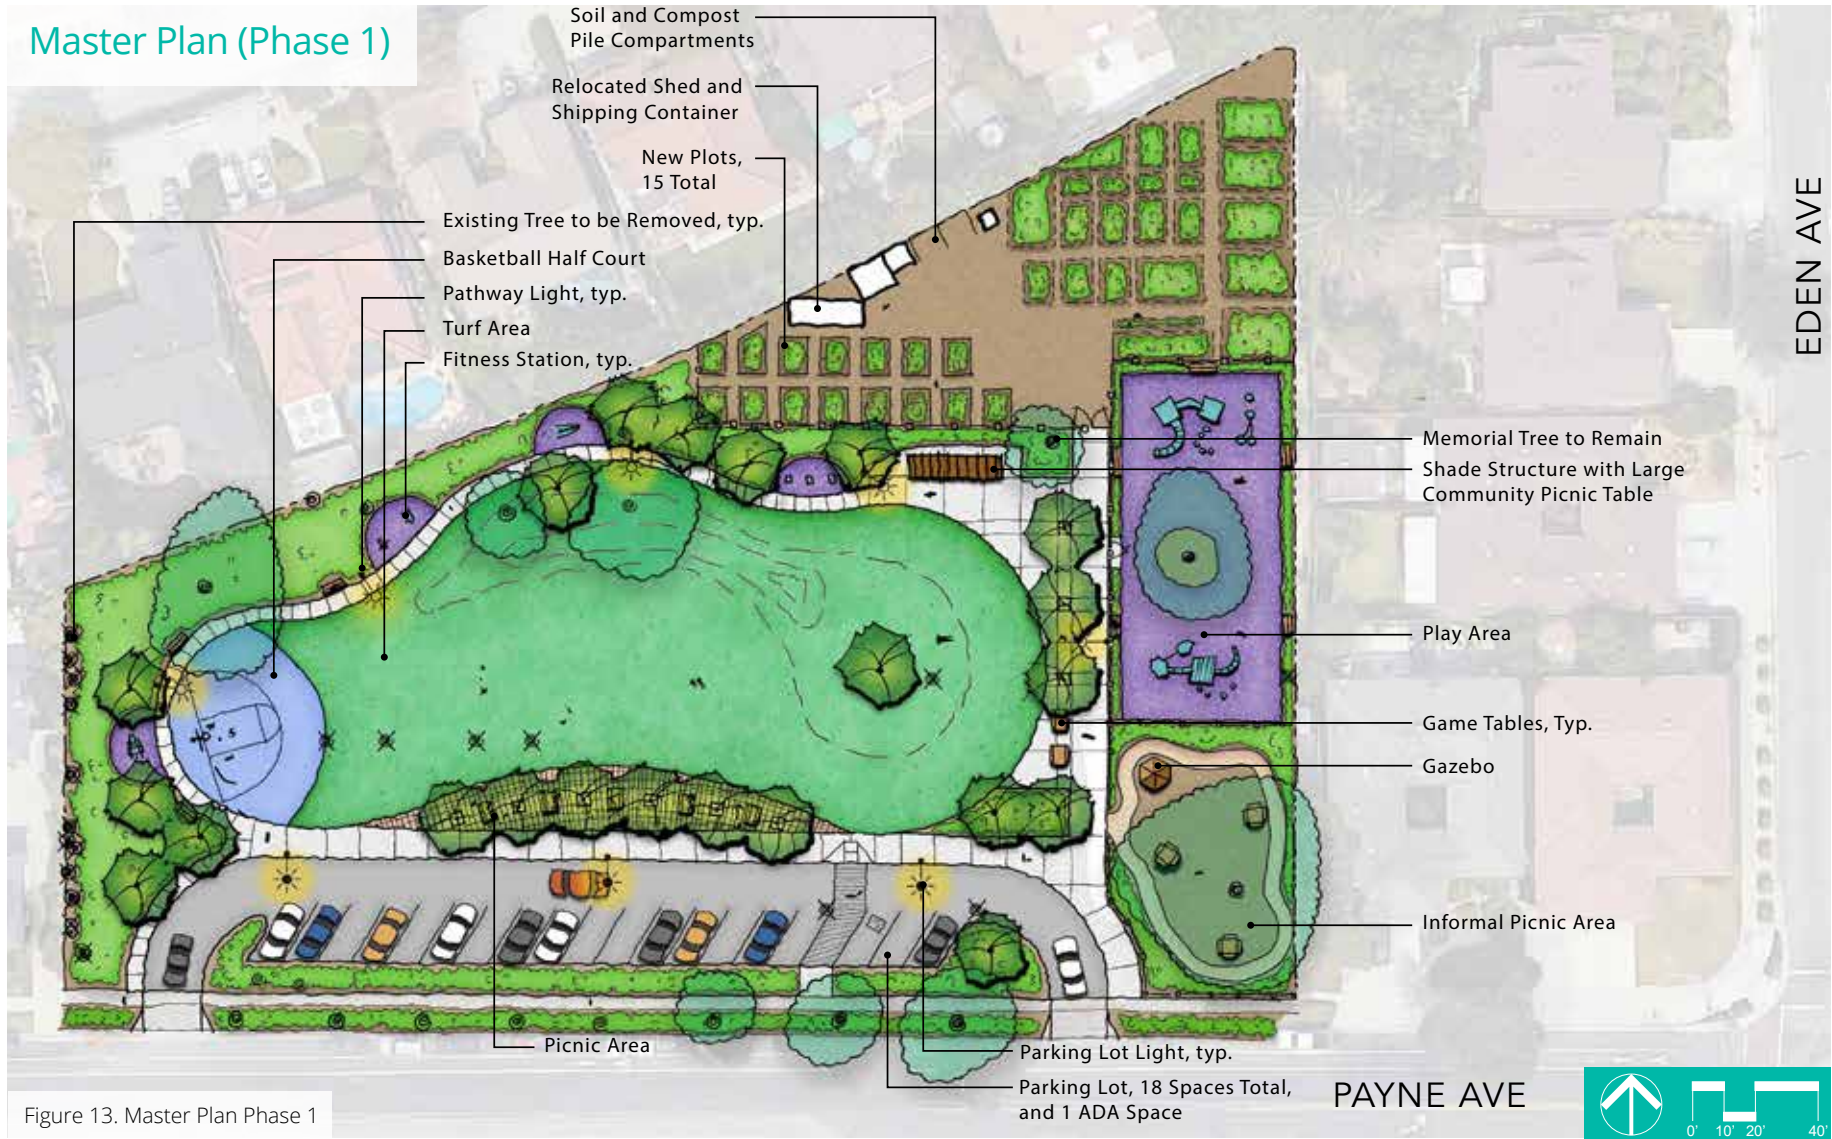
Figure 13. Master Plan Phase 1

Master Plan (Phase 1)

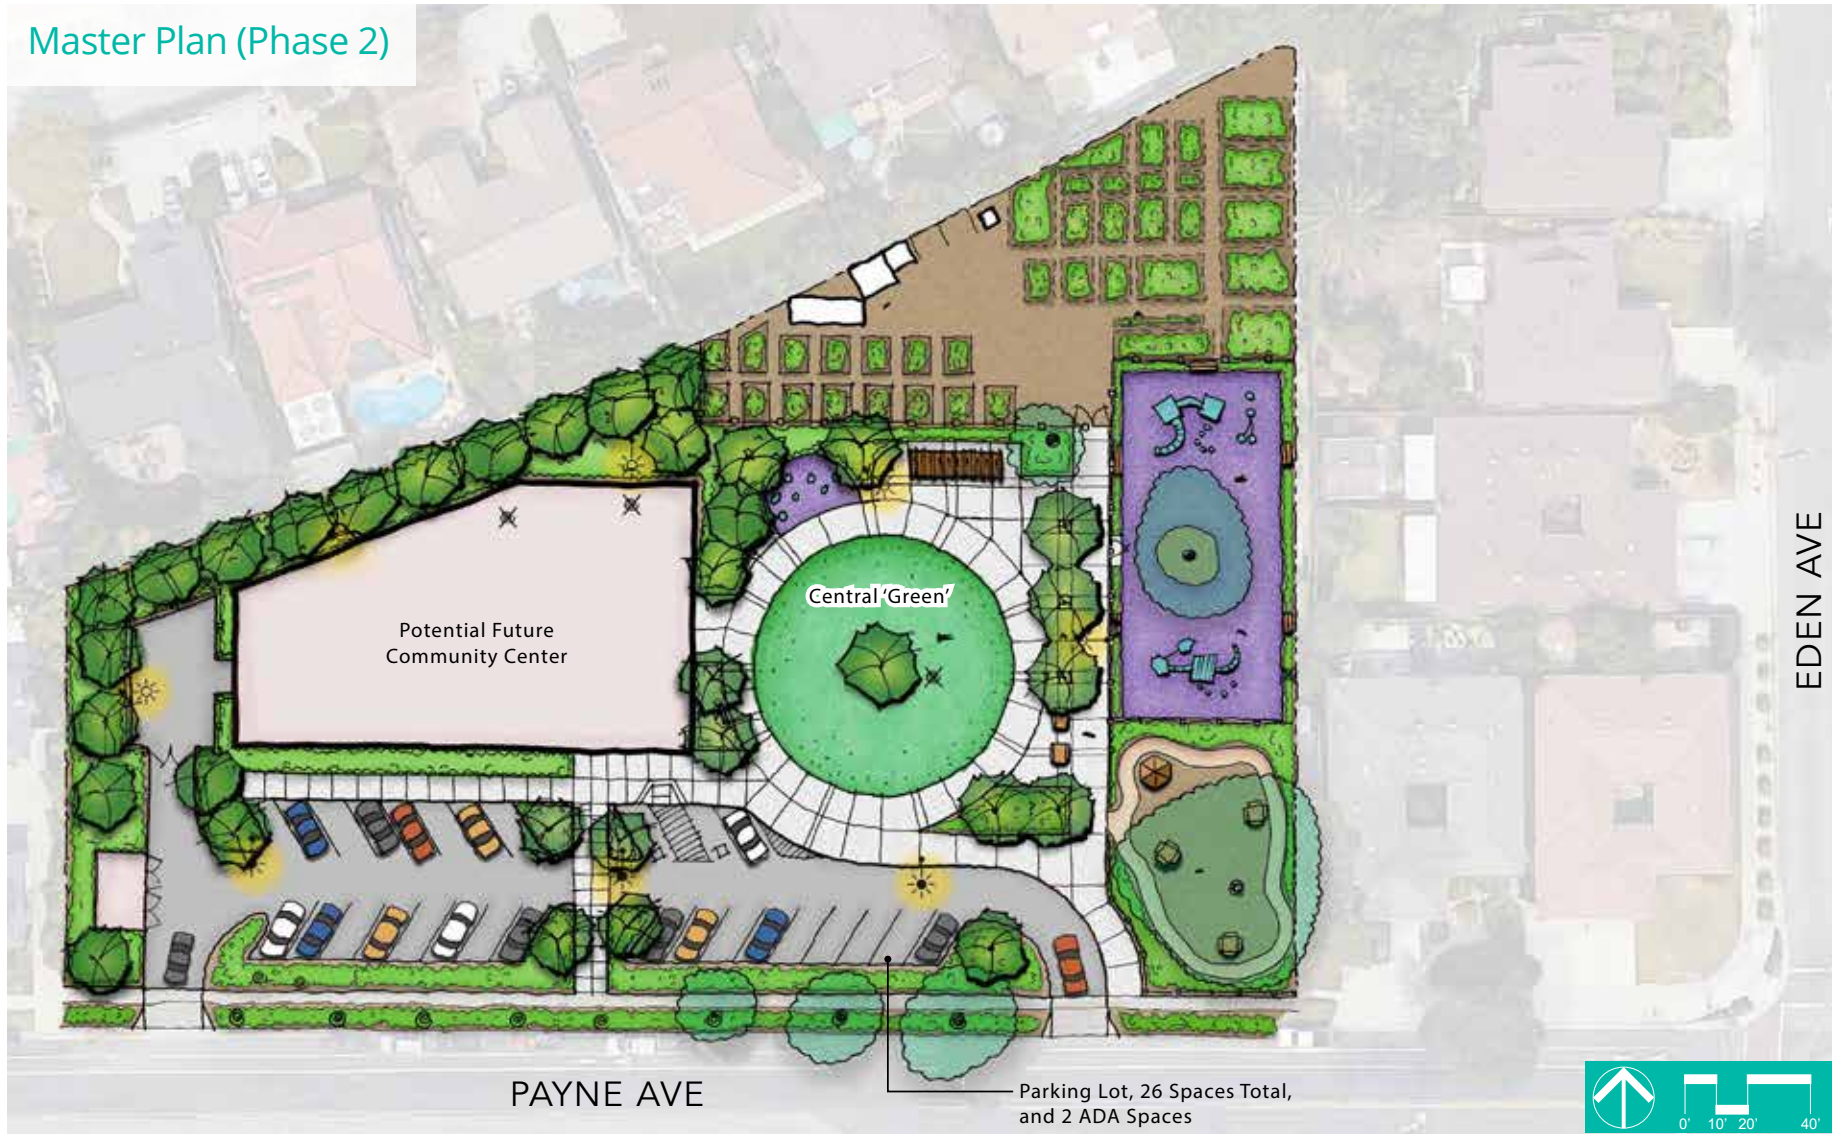
Figure 14. Master Plan Phase 2

Master Plan (Phase 2)

Development of phase 2 will occur upon allocation of additional resources by the City Council.

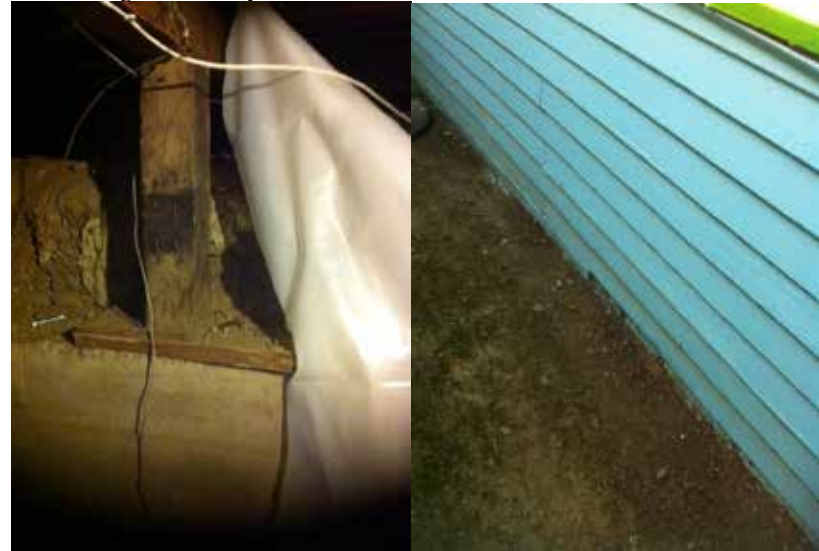
Photos 1 and 2.

In examination of the basement, it appears the structure is not bolted to the foundation, and is therefore subject to being severely damaged in a seismic event and pose a hazard to building occupants. (see photos 1). In addition, the foundation exterior on the east and west sides of the house exhibit evidence of concrete spalling, and possible soil shifting. (see photo 2).The house would need to be bolted to the foundation at a minimum, with possible other foundation work needed. Note that a more thorough foundation inspection would need to be conducted by a structural engineer to verify the visual observations.

The exterior siding of the structure appears to have areas of dry rot, and also comes within 1" of the soil line in places. (see photo 2). Parts of the siding would need to be replaced.

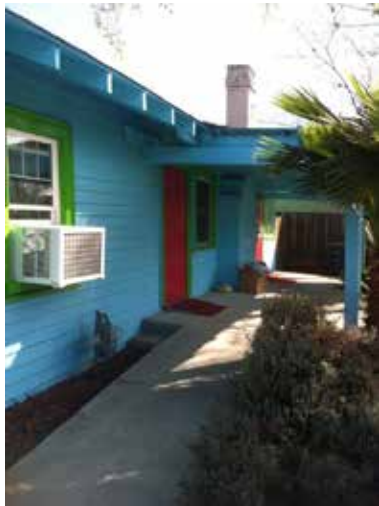
Photo 3.

In examining the masonry chimney, it appears to be a non-reinforced masonry, as it is leaning outward slightly away from the roof. In a seismic event, it could collapse in on top of the front porch cover. (see photo 3). The chimney would need to be removed.

The concrete ramp to the front entrance is of a slope greater than 1:12, and does not have handrails, curbs, or visual warning strips. The porch to house front door threshold is greater than 1/2", and has been adjusted using a metal transition strip, which does not meet current CBC standards. (see photo 3). In addition, the eastern most front door entrance is lacking the code required door hardware and side clearance (24") on the pull side. The front ramp, porch entry, door, door threshold and hardware would need to be replaced.

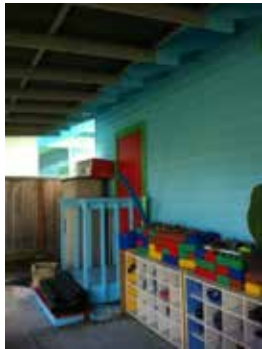
Photo 4.

In examining the rear porch cover, the framing and bolting of the cover framing are of a non-standard nature, and likely added later. There appears to be dry rot in several areas of the plywood covering the framing. Additionally, the cover framing members are bolted to the ends of the roof framing, which is structurally hazardous, as the ends of framing members are not rated to carry the added loads of this nature. In a seismic event, the porch cover could collapse thereby preventing exit from the building. (see photo 4). The rear porch cover would need to be removed.

The rear exits consist of wood stairs and handrails which do not comply with current CBC or ADA standards. The stair treads are not CBC compliant for step height or width, and landing size, and the handrails do not meet current ADA or CBC standards regarding spacing of vertical pickets, or height and construction of the rails. Both rear exit structures would need to be replaced with new ramps with compliant handrails. (see photo 4).

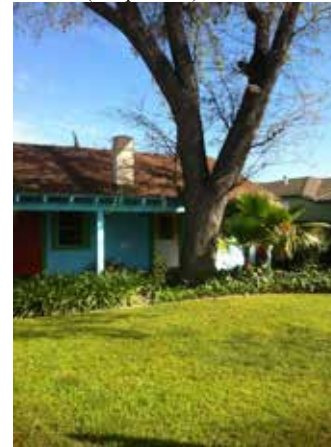
Photo 6.

A triple trunk oak tree of approx. 40" in diameter is growing directly against the edge of the southeast corner of front porch cover, with one trunk leaning towards the house. In a wind event, it is possible the large tree could fail, and thereby cause significant damage to the roof of the structure. An arborist would need to be consulted regarding the stability of the tree, and possible removal of the front porch cover to ensure the safety of the building occupants, if the tree were to remain. (see photo 6).

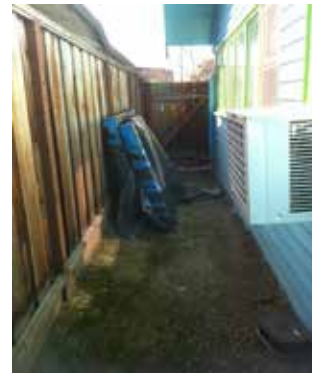
Photo 7.

The eastern roof line of the structure (wood construction) appears to be approximately 1'-6" from the east property line. The California Building Code (CBC) requires at least 5 feet from any wooden structure to the property line, to prevent the spread of fire. (see photo 7). The roof line would need to be cut back to achieve the minimum clearance.

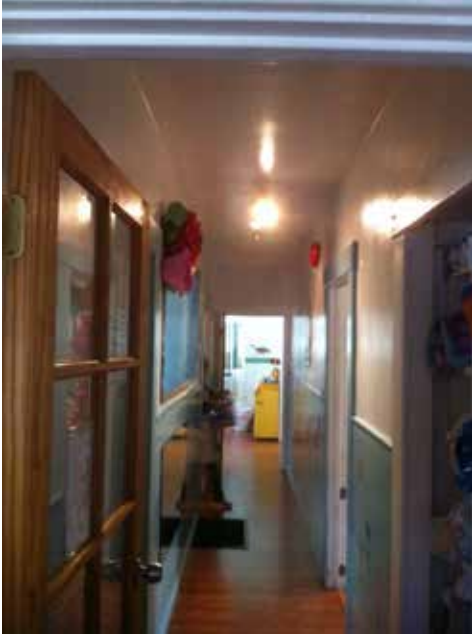
Photo 8.

The 3 existing exits (1 front and 2 rear) consist of residential style doors, without the required exit signage or door hardware that would be required in an A occupancy. In accessing the rear exits, occupants would be exiting through adjoining rooms (the kitchen and a playroom), and also a hallway that does not comply with ADA standards for width. The hallway would need to be widened, one of the rear exits made part of the hallway by removal of the intervening room, and the exit doors retrofitted to meet current standards. (see photo 8).

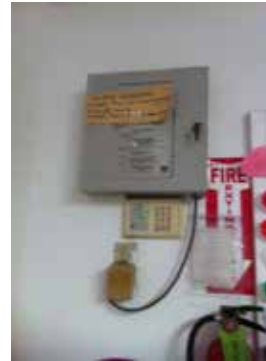
Photo 9.

The fire alarm is not acceptable for use in an A occupancy, due to use of an alarm battery charger wired to an outlet, which is considered substandard construction. (see photo 9) There are no horns or strobes, and a single smoke detector and alarm bell. The entire structure would need to be rewired to city standards and a new fire alarm system installed.

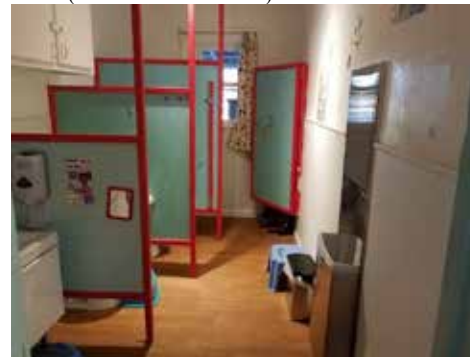
Photo 10.

Both Boys and Girls restrooms do not comply with ADA requirements for size of the rooms, and size and placement and height of plumbing fixtures. All fixtures would need to be removed and replaced, with the possibility that each restroom would need to be converted to a single use due to the room size constraints. The code requires that floors, and other adjacent surfaces next to sinks and toilets be waterproof, and the current finishes of both floors which are plastic laminate, and stall partitions, which are painted wood, do not comply. (see photo 10). Both restrooms would need to be gutted and rebuilt. In addition, new doors and ramps to the restrooms would need to be built. (see ADA deficiencies).

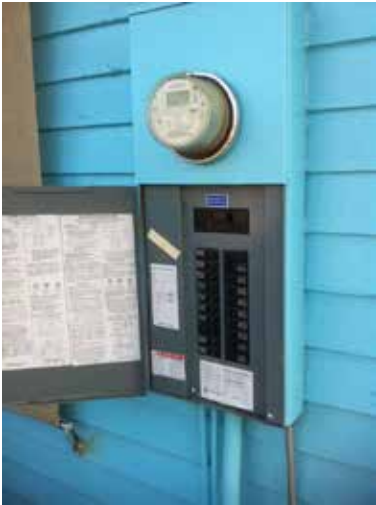
Photo 11.

The electrical subpanel appears to have been replaced several years ago, and appears serviceable for the current use. However, the electrical service main appears to be of a low Amperage, and not adequate for installation of new lights, fire alarms, restroom equipment, and other electrical service needs. The service would need to be upgraded to at least a 200 AMP service or greater, which would require new electrical equipment, as well as a new PG and E service main. (see photo 11). The actual amperage needed for a new or upgraded facility would need to be verified by an electrical engineer.
