| Client Name | San Jose Mineta International Air | San Jose Mineta International Airport | | |
|---|--|---|---|--|
| Project Name | SJC Facility Condition Assessment | SJC Facility Condition Assessment | | |

Executive Summary

Facility Condition Assessment

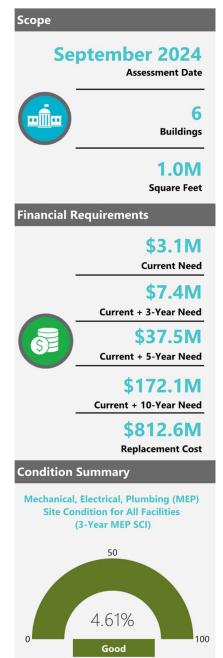
Figure 2. Current Plus 10-Year Cost of Repairs

For the SJC facilities, \$3.1 million in current deficiencies were identified. In addition, projected capital renewal forecast needs over the next 10 years totals \$169.0 million. Combining current deficiencies with the next 10 years of forecasted capital renewal needs, SJC can anticipate \$172.1 million in facility related needs. Figure 2 details the cost of need currently and over the next 10 years.

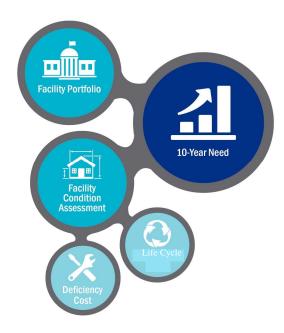
Figure 3. FCA Four Key Steps

The assessment and development of the financial forecast are based on four key steps, which are depicted in Figure 3 and described in detail in the following sections.

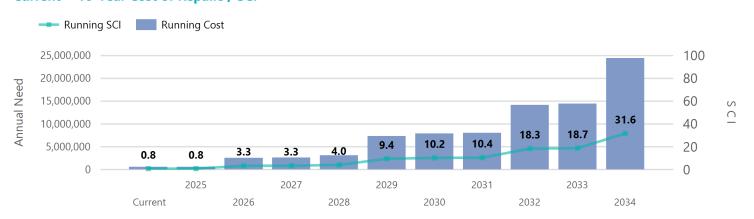
Current + 10-Year Cost of Repairs / SCI

Current + 10-Years 2025 2030 2026 2027 2028 2029 2031 2032 2033 2034 System Current **Total** Mechanical \$372,862 \$0 \$761,948 \$0 \$254,508 \$911,398 \$0 \$144,798 \$1,628,368 \$263,178 \$352,578 \$4,689,638 Electrical \$46,649 \$0 \$0 \$12,224 \$95,746 \$154,082 \$0 \$12,595 \$3,602,274 \$0 \$1,862,234 \$5,785,804 Plumbing \$0 \$0 \$0 \$0 \$0 \$154,164 \$567,268 \$135,781 \$0 \$7,483,459 \$8,340,672 \$1,208,746 \$292,342 \$0 \$1,501,088 Fire & Life Safety \$0 \$0 \$0 \$0 \$0 \$0 \$0 \$0 \$0 \$0 \$0 \$0 \$0 \$0 \$0 Technology \$0 \$0 \$0 \$0 \$0 Conveyances \$168,469 \$0 \$0 \$0 \$187,102 \$2,958,301 \$0 \$0 \$486,732 \$0 \$296,908 \$4,097,512 \$0 Security \$0 \$0 \$0 \$0 \$0 \$0 \$0 \$0 \$0 \$0 \$0 \$587,980 \$1,970,694 \$12,224 \$537,356 \$4,177,945 \$567,268 \$157,393 \$6,145,497 \$263,178 \$9,995,179 \$24,414,714 Total:

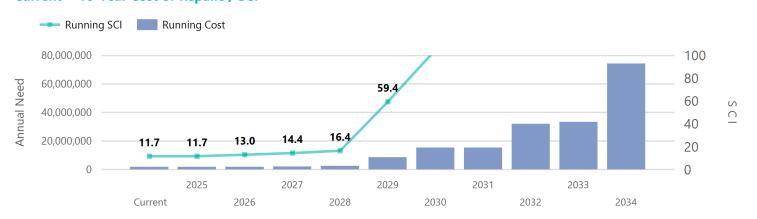
Current + 10-Year Cost of Repairs / SCI

| | | | | | Cı | ırrent + 10-Yea | ırs | | | | | |
|---|---|---|---|---|---|---|---|---|---|---|---|---|
| Total: | \$1,689,077 | \$0 | \$190,487 | \$455,548 | \$293,316 | \$6,222,118 | \$6,610,670 | \$21,389 | \$16,673,251 | \$1,309,015 | \$40,978,353 | \$74,443,224 |

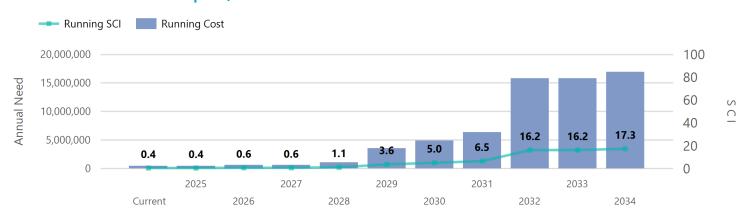
Current + 10-Year Cost of Repairs / SCI

Current + 10-Years 2030 2025 2026 2027 2028 2029 2031 2032 2033 2034 System Current **Total** \$1,060,042 Mechanical \$406,761 \$0 \$190,487 \$0 \$0 \$0 \$0 \$2,227,812 \$0 \$0 \$3,885,102 \$407,629 Electrical \$9,704 \$0 \$1,702 \$0 \$299,594 \$317,367 \$817,153 \$4,731,258 \$0 \$1,096,568 \$7,680,975 Plumbing \$0 \$0 \$0 \$0 \$0 \$310,939 \$719,413 \$94,378 \$0 \$0 \$1,124,730 \$317,859 \$2,432,582 \$0 \$2,750,441 Fire & Life Safety \$0 \$0 \$0 \$0 \$0 \$0 \$0 \$0 \$0 \$0 \$0 \$0 \$0 \$0 \$0 \$0 \$0 Technology \$0 \$0 \$0 Conveyances \$21,858 \$0 \$0 \$0 \$0 \$828,411 \$0 \$622,528 \$0 \$0 \$0 \$1,472,797 \$0 Security \$0 \$0 \$0 \$0 \$0 \$0 \$0 \$0 \$0 \$0 \$0 \$438,323 \$192,189 \$407,629 \$2,498,986 \$1,354,639 \$1,439,681 \$9,486,030 \$1,096,568 \$16,914,045 Total:

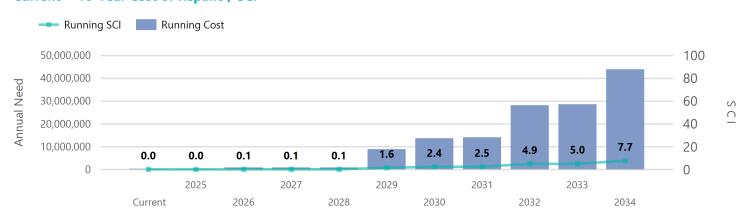
Current + 10-Year Cost of Repairs / SCI

| | | Current + 10-Years | | | | | | | | | | |
|---|---|---|---|---|---|---|---|---|---|---|---|---|
| Total: | \$243,404 | \$0 | \$571,461 | \$0 | \$0 | \$8,104,231 | \$4,689,608 | \$416,711 | \$14,134,269 | \$385,558 | \$15,367,415 | \$43,912,657 |

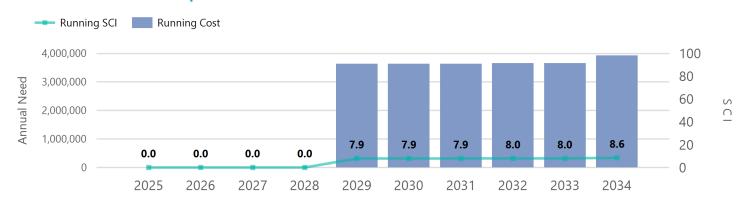
Current + 10-Year Cost of Repairs / SCI

Current + 10-Years 2025 2026 2027 2028 2030 2029 2031 2032 2033 2034 Total System Current \$1,606,249 Mechanical \$0 \$0 \$0 \$0 \$0 \$0 \$0 \$0 \$0 \$22,283 \$1,628,532 \$0 Electrical \$0 \$0 \$0 \$0 \$0 \$11,581 \$0 \$0 \$0 \$0 \$11,581 Plumbing \$0 \$0 \$0 \$0 \$0 \$108,316 \$0 \$0 \$20,085 \$0 \$253,882 \$382,283 \$0 \$0 \$919,213 \$0 \$0 \$0 \$919,213 Fire & Life Safety \$0 \$0 \$0 \$0 \$0 \$0 \$0 \$0 \$0 \$0 \$0 \$0 \$0 \$0 Technology \$0 \$0 \$0 Conveyances \$0 \$0 \$0 \$0 \$0 \$990,135 \$0 \$0 \$0 \$0 \$0 \$990,135 \$0 \$0 \$0 \$0 \$0 Security \$0 \$0 \$0 \$0 \$0 \$0 \$0 \$0 \$0 \$0 \$3,635,494 \$0 \$0 \$20,085 \$0 \$276,165 \$3,931,744 Total:

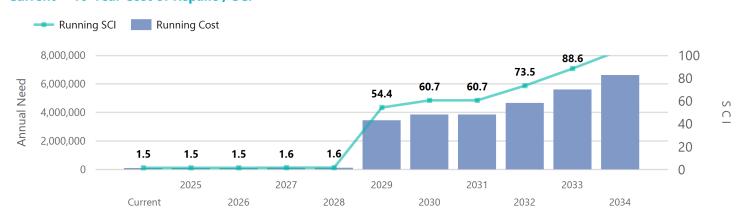
Current + 10-Year Cost of Repairs / SCI

| | | | | | Cı | ırrent + 10-Yea | ars | | | | | |
|---|---|---|---|---|---|---|---|---|---|---|---|---|
| Total: | \$92,793 | \$0 | \$0 | \$1,004,906 | \$1,442 | \$4,164,655 | \$397,574 | \$0 | \$815,462 | \$951,634 | \$1,020,164 | \$8,448,630 |
