# City of San José Stormwater Management *Annual Report 2018-2019*

# **City of San José**

## **Stormwater Management**

### **Annual Report 2018-2019**

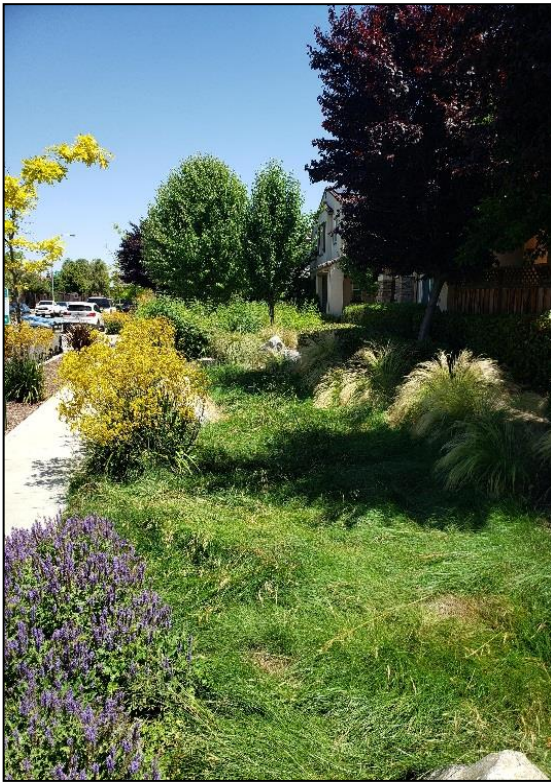
*Bioretention installation in a residential area.*

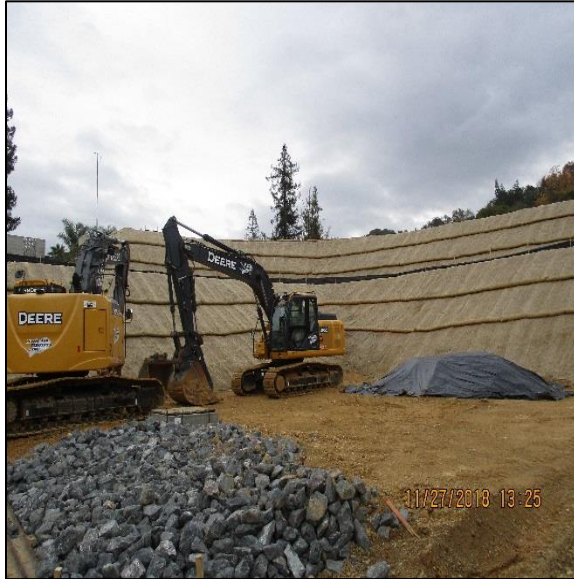
*Effective BMPs installed on a hillside construction site.*

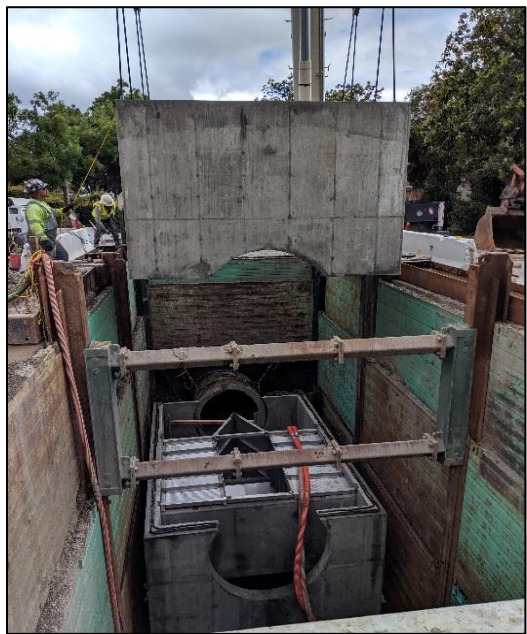
*Installation of an HDS device at Rock Springs Drive.*

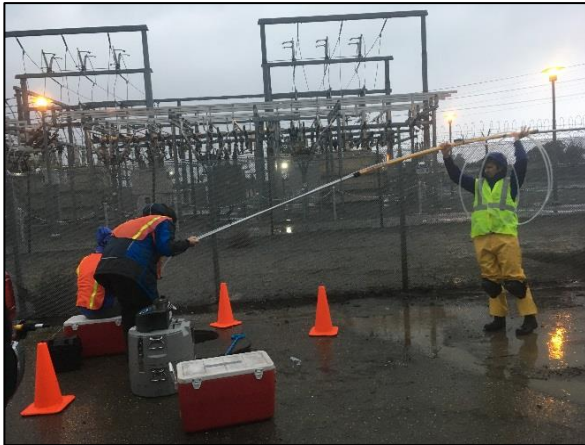
*Regional Monitoring Program staff collecting PCB samples from a manhole.*

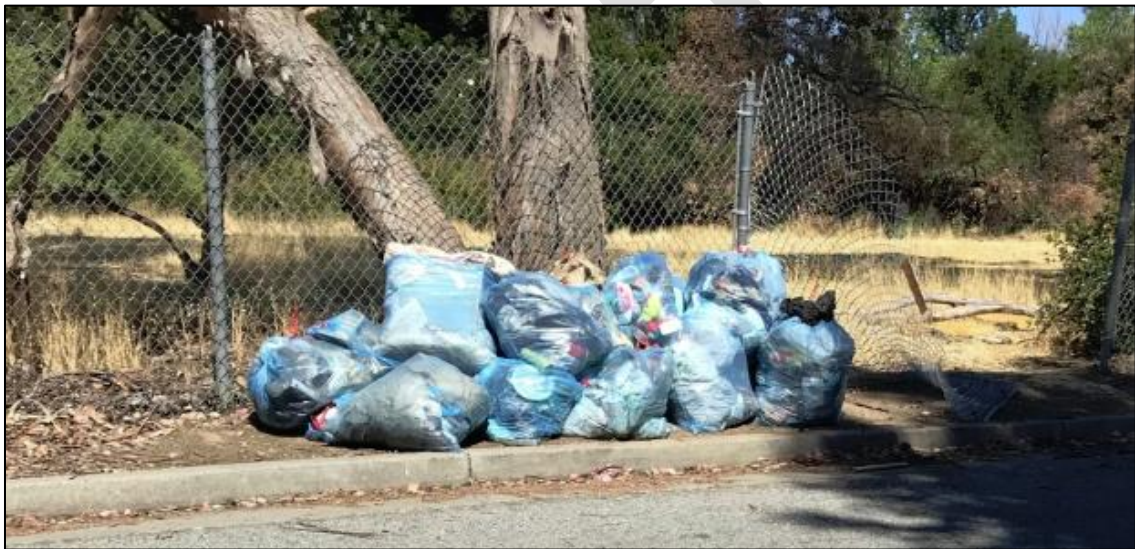
*A pile of blue trash bags from homeless residents along Coyote Creek south of Singleton Road.*

- 1.3.2 The “Blue Bag” effort was formalized in spring of 2019 along Coyote Creek and Guadalupe River. Outreach workers, Anti-Litter Program, ESD staff, and Park Rangers are distributing blue trash bags to encampment residents to educate and encourage them to bag their trash. The bags are transparent to discourage rummaging and unique in color to track more easily. Piles of bags are collected by City and Valley Water staff. Staff has recorded over 100 bags collected this year, with many more possibly collected, but mixed in with other trash piles.

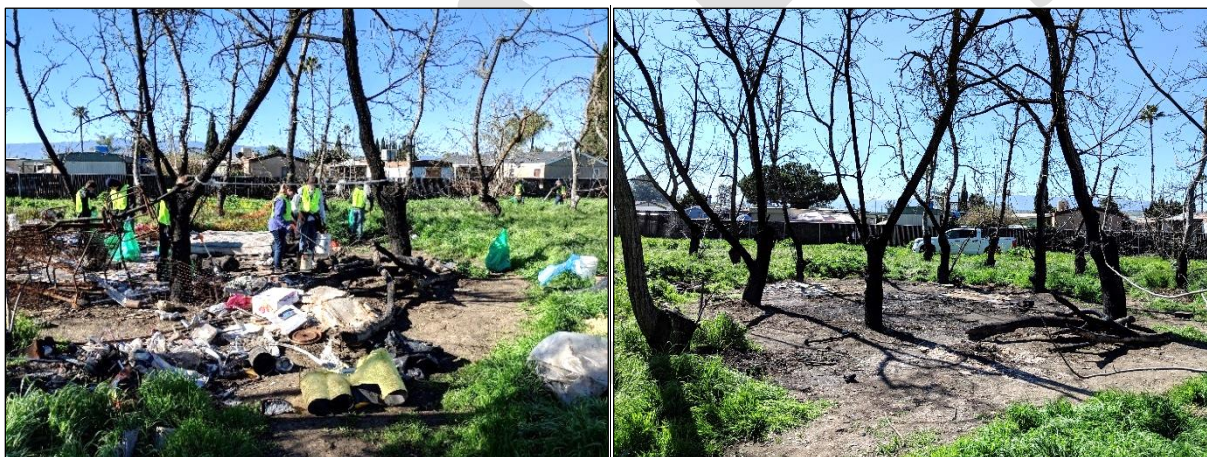
*Before and after photos of volunteer cleanup at Coyote Creek, downstream of Tully Road.*
