City of San José Stormwater Management

ANNUAL REPORT 2024-25

Annual Report 2024-2025

September 2025

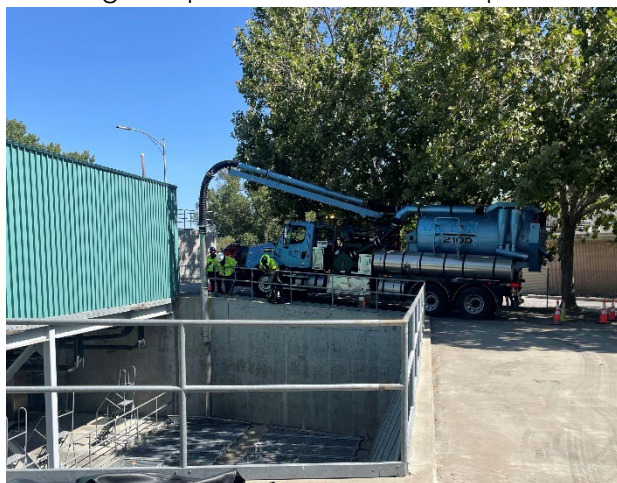
Wet well cleaning of the Oakmead Pump Station

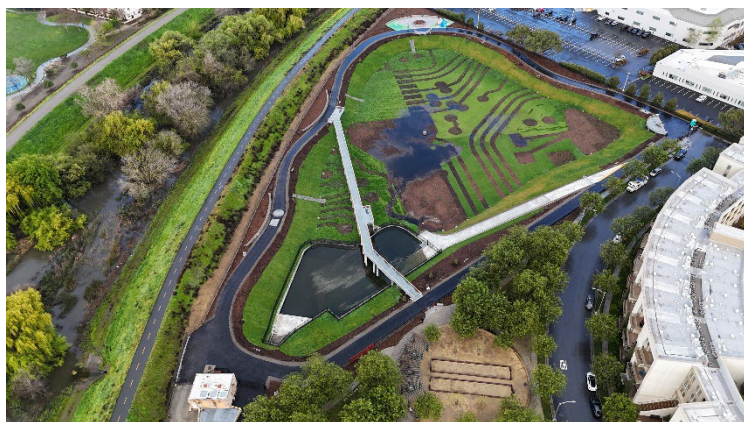
Aerial view of the new Riverview Stormwater Garden

On April 9, 2025, the City held a ribbon-cutting for its newly-completed Riverview Stormwater Garden, Santa Clara County's first regional GSI installation. This project recently received the California Stormwater Quality Association's 2025 award for Outstanding Stormwater Capture and Use Implementation Project. This award-winning project converted existing flood management basin into a bioretention basin and park that treats stormwater runoff from approximately 340 acres of north San José, fulfilling the Stormwater Permit requirement to construct GSI. The Stormwater Garden is both City Park and stormwater treatment, featuring a sediment forebay, bioretention basin, a pedestrian bridge, and a footpath around the basin featuring educational signage to educate the public on the Stormwater Garden's role in protecting water quality, climate resilience, and biodiversity. An informational website was created to provide in-depth

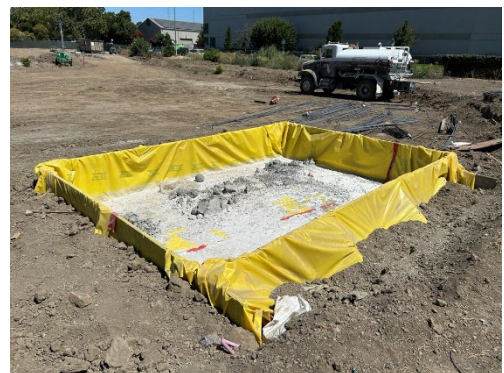
A properly lined and installed concrete washout at an active construction site.

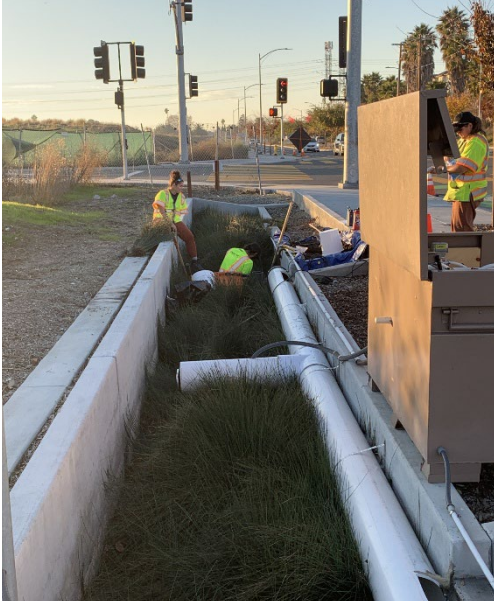
N First Street LID Monitoring in Alviso

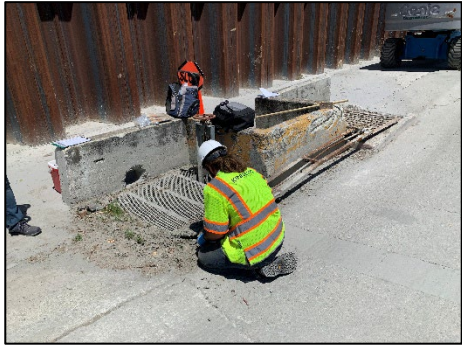
Sampling storm drain catch basins at a potential PCB source property.

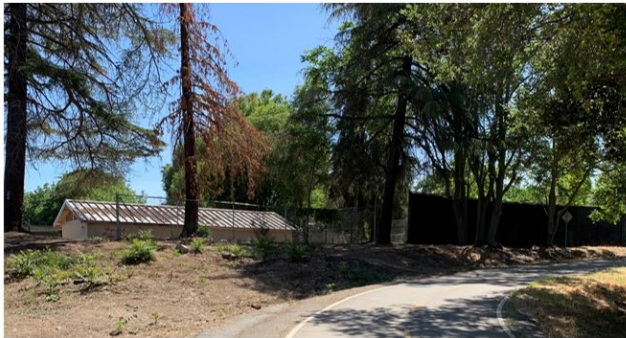
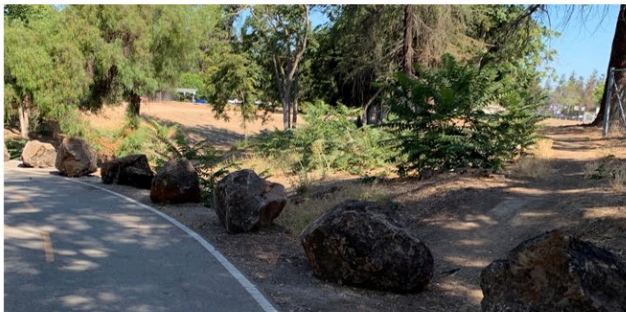
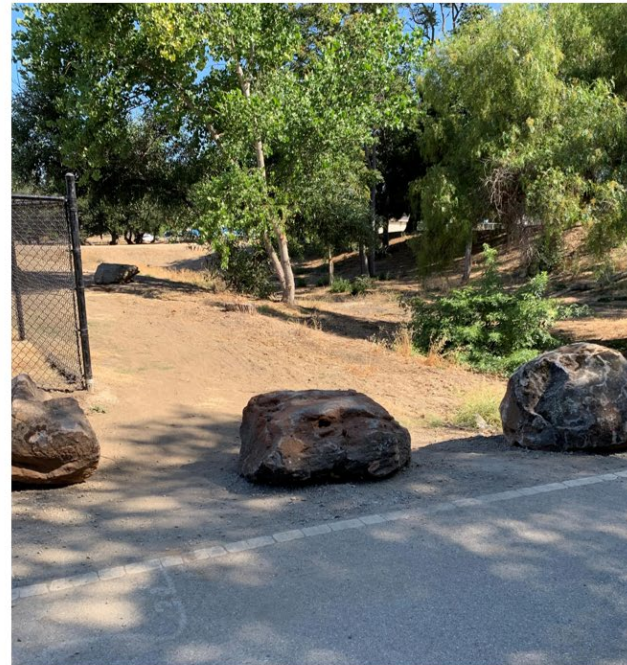
Fencing installations at Tully Minor Ballfield, including 150 feet along the foul ball line and a 70-foot perimeter enclosure, to deter encampments near Coyote Creek.

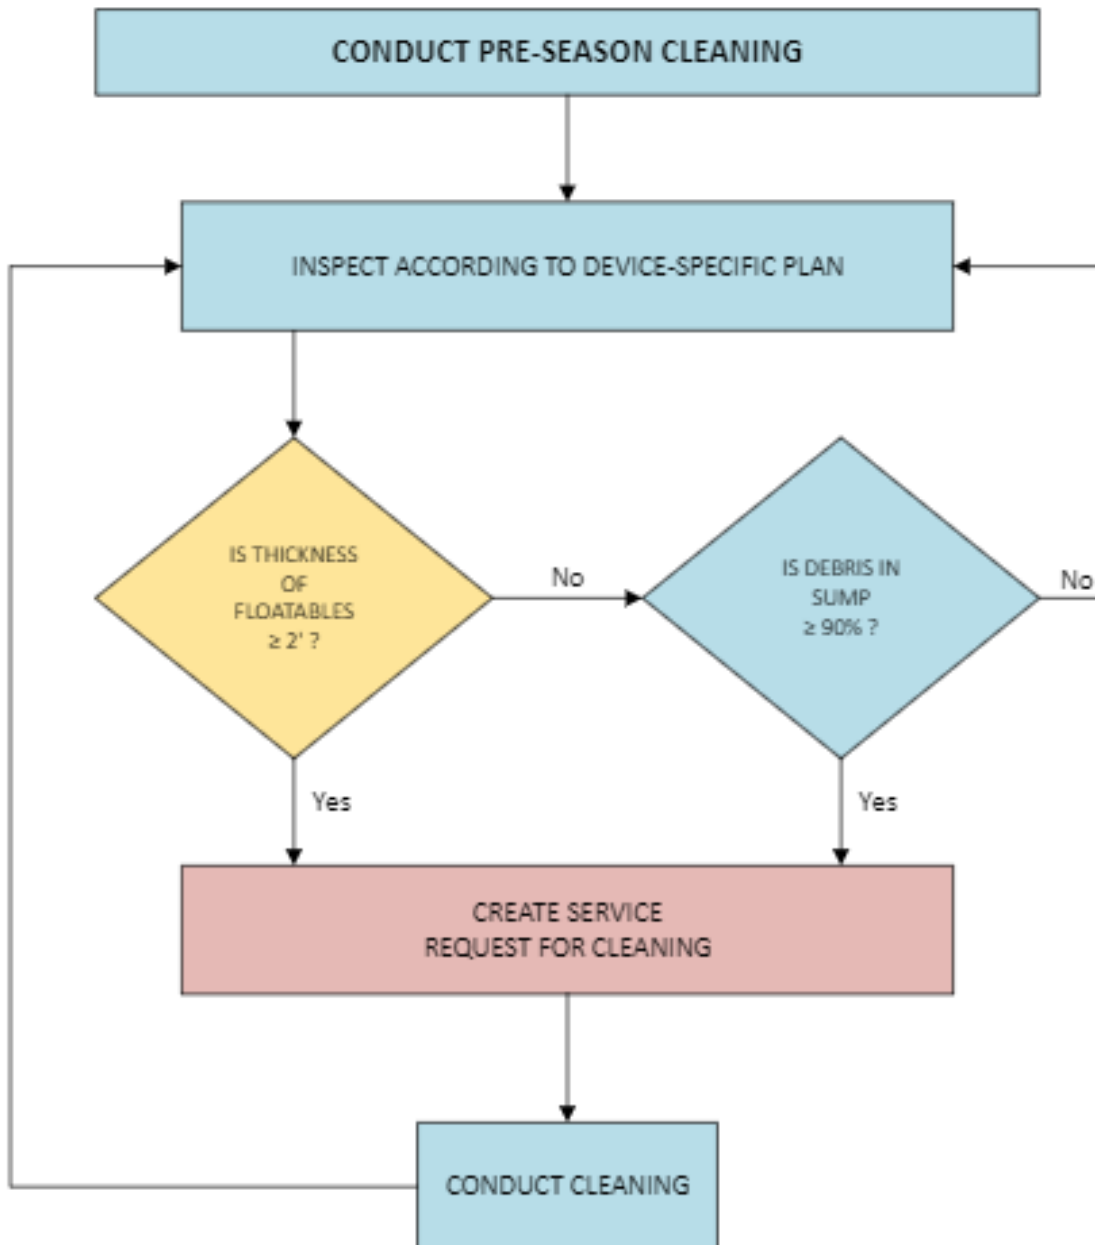
C.10 CDS DEVICE MAINTENANCE FLOW CHART

Maintenance Flow Chart
